2019 Operations Report, Appendix H - 2019 Leachate Collection System, Purge Well Gravity Drain and Groundwater Gallery Cleaning and Inspection Report

City of Barrie

Golder Associates Ltd.

June 2020

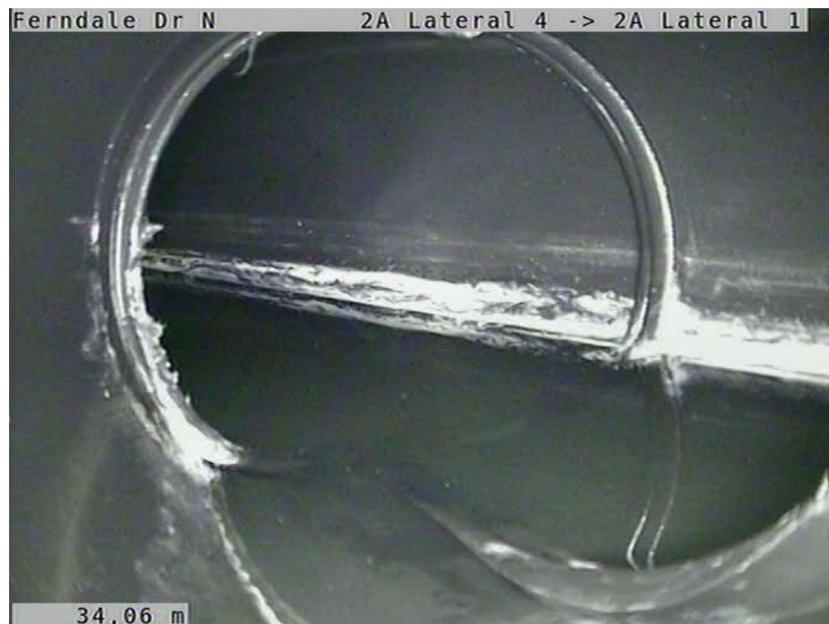
Photo 1: Typical cleanout connection to LCS laterals in Cells 2A and 3A.

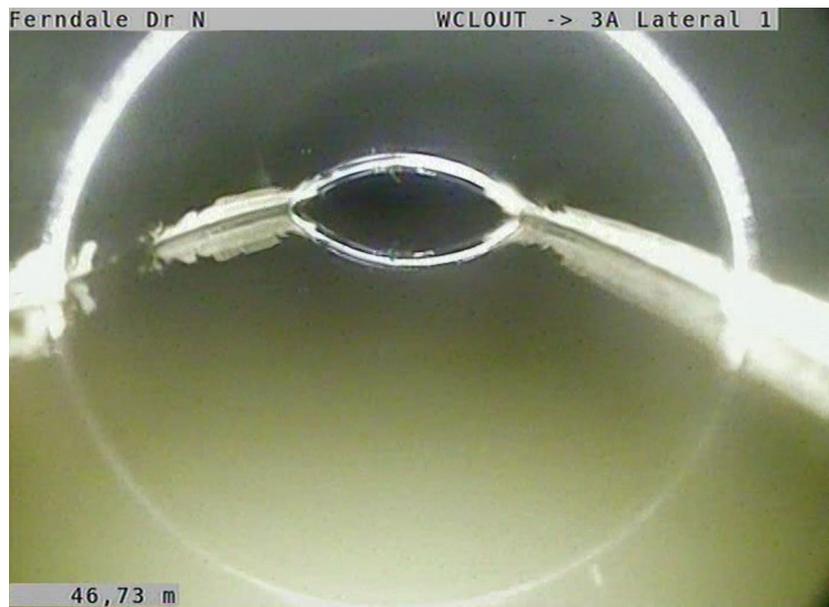
Photo 2 shows the condition within the west cleanout access to 3A Lateral 1 at approximately 47 m from the cleanout entrance. Sumping observed in this area is further supported by the video inspection of the 3A West Header, which also indicates a sump condition, as shown in Photo 3. During the inspection, the camera was able to navigate beyond the sump in the 3A Lateral 1 pipe and the entire length of the lateral was inspected. The inspection indicates that the 3A Lateral 1 is not plugged and is draining towards the maintenance chamber in Cell 3A; typical 3A Lateral 1 conditions are shown in Photo 4.

Photo 2: Sumping (as observed in 2019) within west cleanout access to 3A Lateral 1 at approximately 47 m.

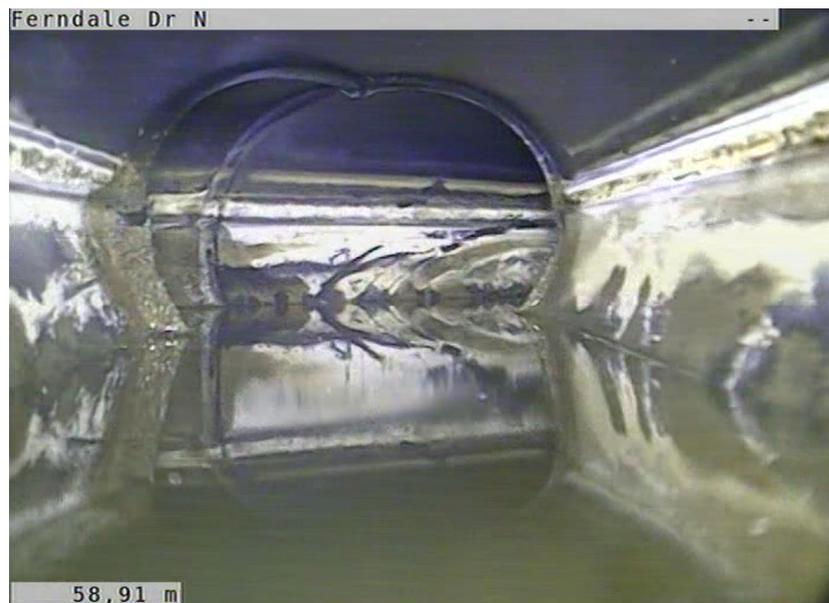
Photo 3: Sumping (as observed in 2019) within 3A West Header at approximately 59 m.

- The portion of Cell 2A and 3A LCS that can be inspected appears to be in a good condition. Leachate flows appear unobstructed, with the exception of the northern extent of the 3A West Header where some sumping (a low point in the pipe) is observed, causing locally high leachate levels within the LCS;

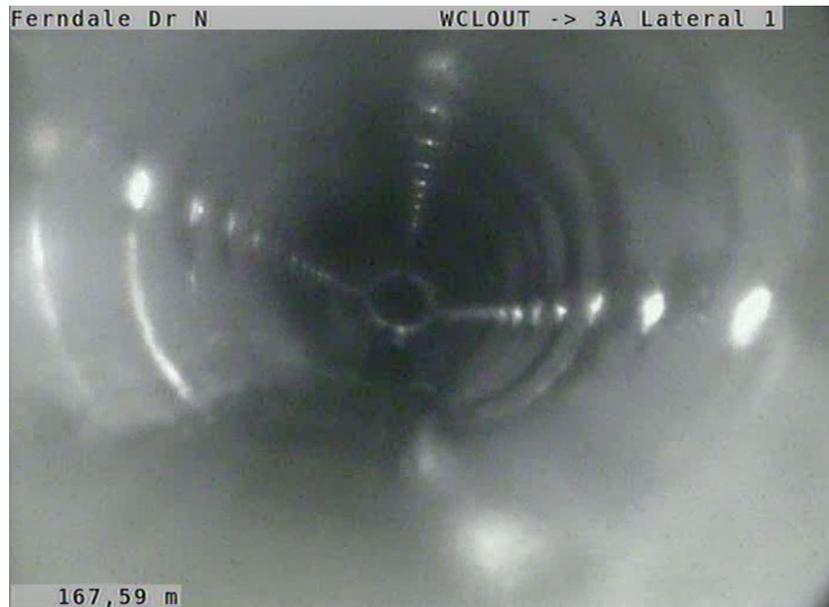
Photo 4: Typical conditions within the 3A Lateral 1.

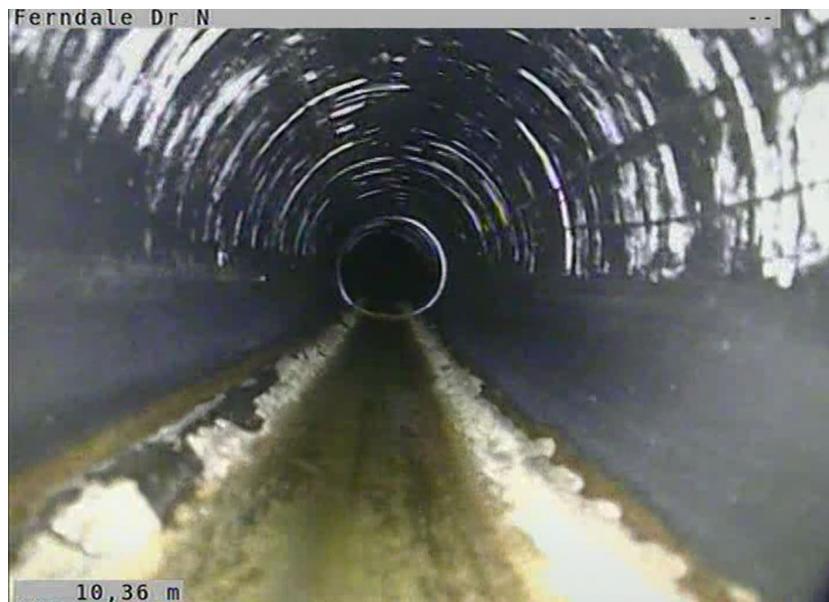
Inspection of the leachate conveyance line between the 3A Maintenance Chamber and MH4 identified small amounts of accumulated sediment / precipitate, which was similarly noted in previous inspection programs (Photo 5).

Photo 5: Leachate conveyance line between 3A Maintenance Chamber and MH4.

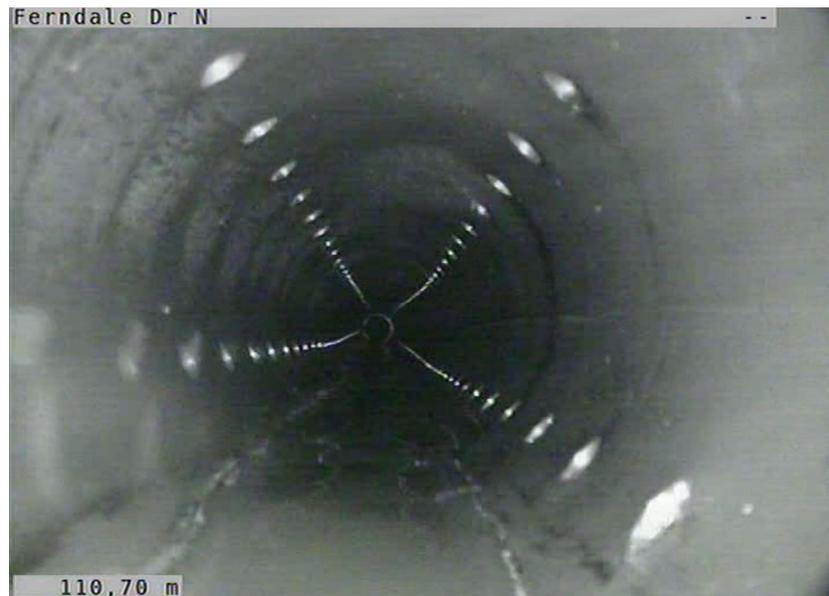
Following cleaning of the 2B / 3B Lateral from the Cell 3B internal maintenance hole, video inspection was conducted. The lateral was inspected to a length of 229 m, short of the 265 m length of this lateral, as the camera was not able to pass a pipe joint. Inspection of the lateral indicated that it was in good condition, as shown in Photo 6.

Photo 6: Typical conditions within the 2B3B Lateral.

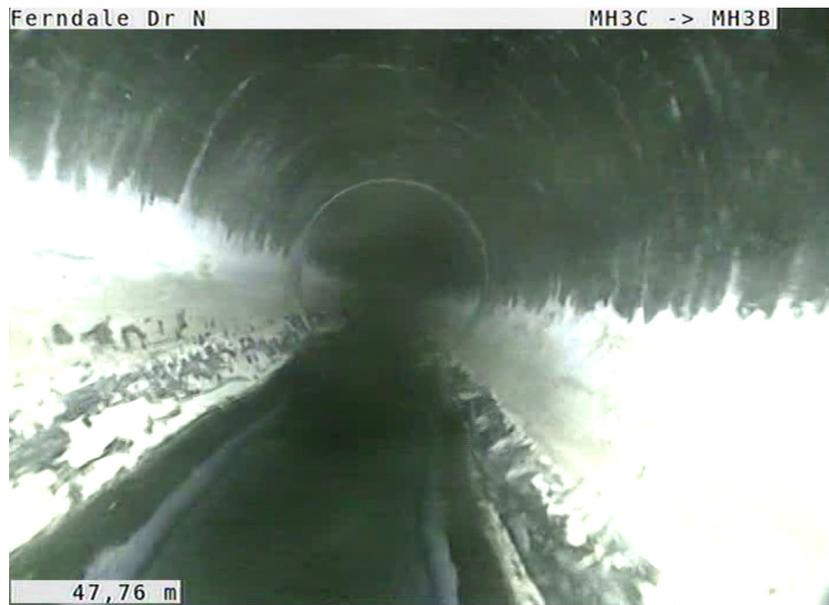
The 3B / 3C West Header was also video inspected and the inspection indicated that the pipe was in good condition (Photo 7). The leachate conveyance pipeline between the Cell 3B internal maintenance chamber and the 3B exterior maintenance chamber was inspected starting at the Cell 3B location and indicated that the LCS was in good condition.

Photo 7: Typical conditions within the 3B / 3C West Header.

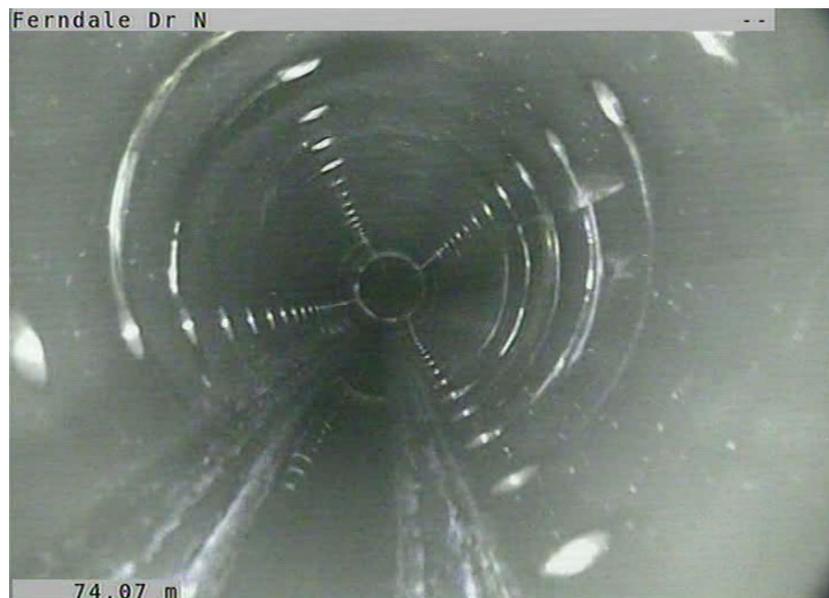
Following cleaning of the 2C / 3C Lateral 1, 2C / 3C Lateral 2 and 2C / 3C Lateral 3, video inspection was conducted. Inspection of the laterals revealed good conditions, as shown in Photo 8. During the video inspection, it was noted there was a piece of concrete debris within the 3C maintenance hole; similar to observations in previous years. The piece of concrete debris was removed by a Sewer Technologies Confined Space Entry Team on December 13, 2019.

Photo 8: Typical conditions within 2C / 3C Lateral 3

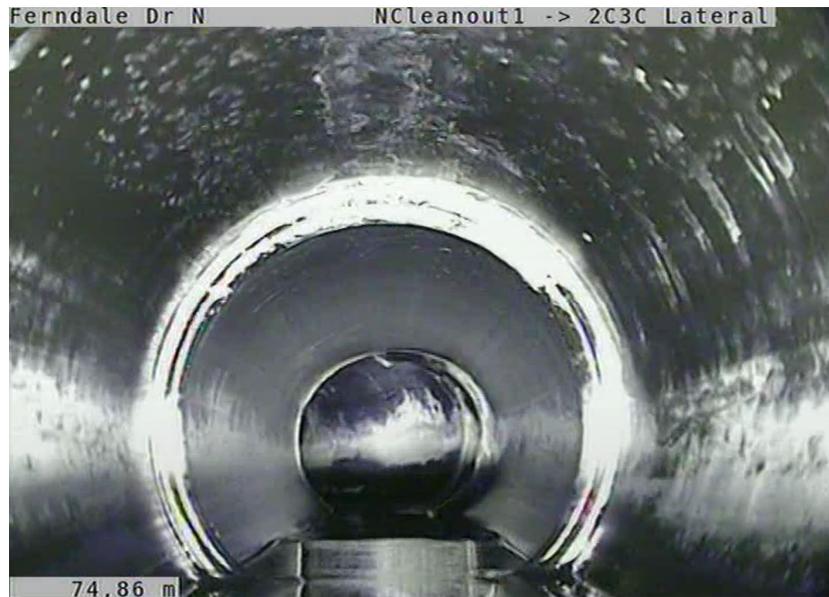
Following cleaning of two cleanouts, NCleanout 1 and NCleanout 2, video inspection was conducted. Inspection of the cleanouts revealed good conditions, as shown in Photo 9.

Photo 9: Typical conditions within NCleanout 1.

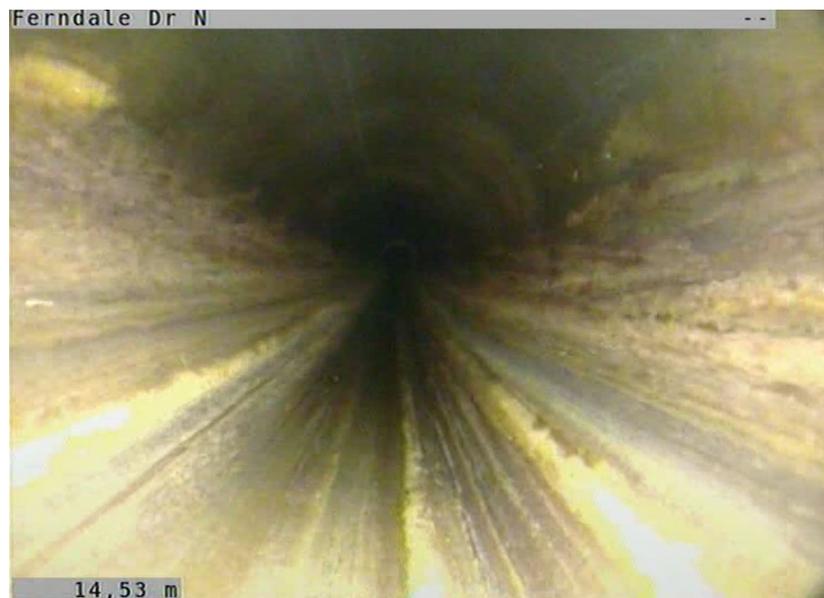
The purge well gravity drain was inspected following the flushing of the pipeline from PW4 to MH4. The PW pumps were stopped during inspection of the PW gravity drain. Each section exhibited sidewall staining consistent with high water levels in the pipe during operation. The flushing operation successfully cleaned the pipes of accumulated silt and precipitate. Typical conditions in the purge well gravity drain can be seen in Photo 10.

Photo 10: Purge well main condition, approximately 15 m downstream of PW2.

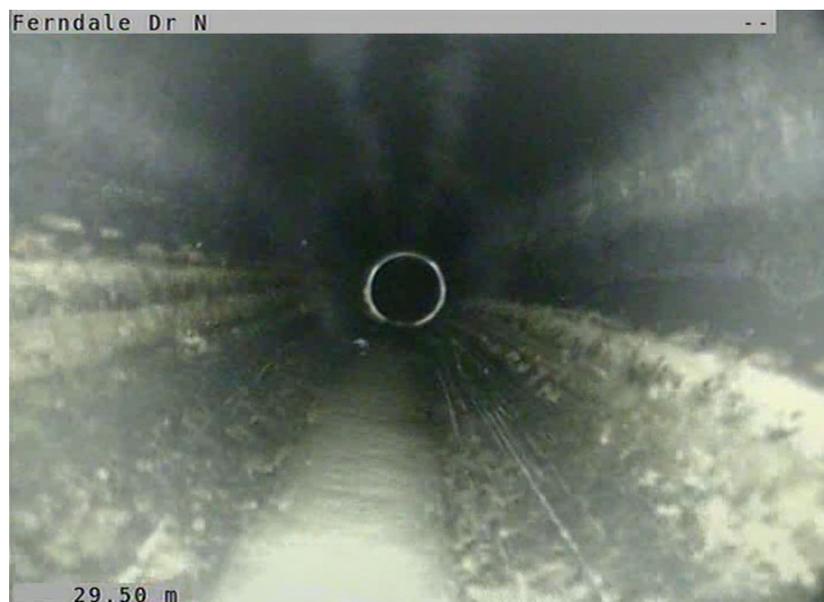
The LCS/PW gravity drain was video inspected sequentially, from MH4 through to MHA, MHB and MHC, and indicated that the pipe was in good condition (Photo 11).

Photo 11: LCS/PW gravity drain condition, approximately 30 m downstream of MHB.

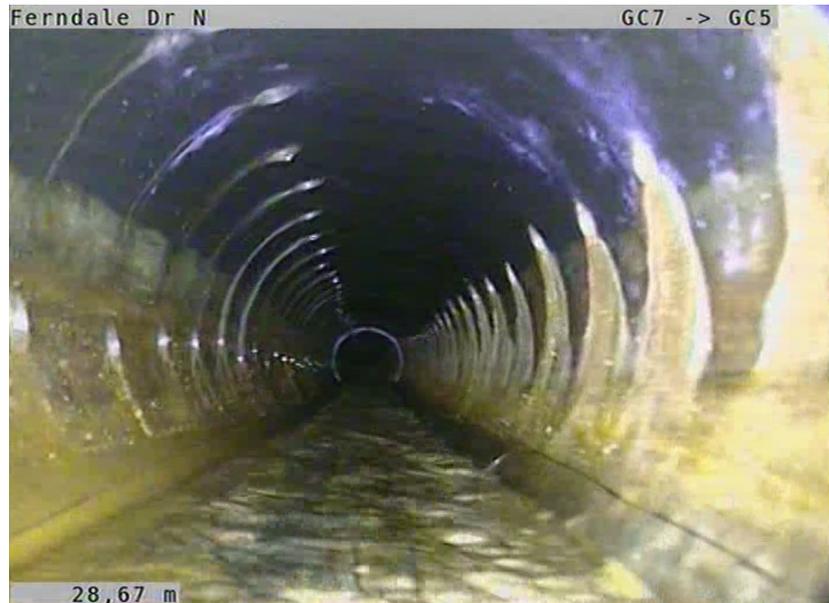
In 2019, the Gallery was inspected following flushing of the Gallery from GC7N to GC1. Based on previous inspection programs, it was anticipated the thickest accumulation of precipitate would be observed in the section between GC7N and GC5N. Although the precipitation in this section was thick, it was soft and appeared to have been completely removed following flushing, as shown in Photo 12.

Photo 12: Typical conditions within Gallery between manholes GC7N and GC5N following flushing.

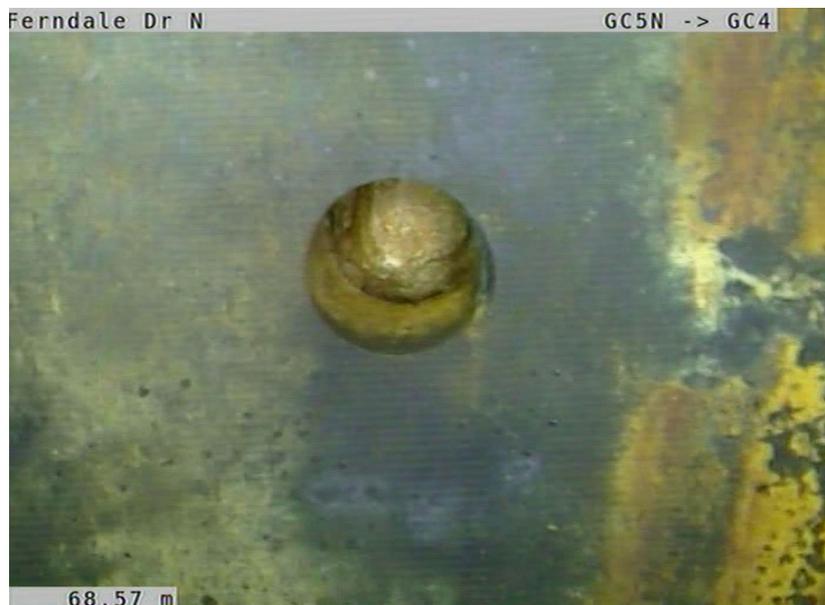
The Gallery section between GC5N and GC4 was inspected following flushing and indicated that this pipe section was in good condition. A video still of a perforation in the Gallery collection pipe is shown in Photo 13. This photo indicates that there was no visible clogging. This condition is considered to represent typical conditions in the Gallery between manhole GC4 and GC5N.

Photo 13: Perforations in the sidewall of the Gallery collector pipe between GC5N and GC4.

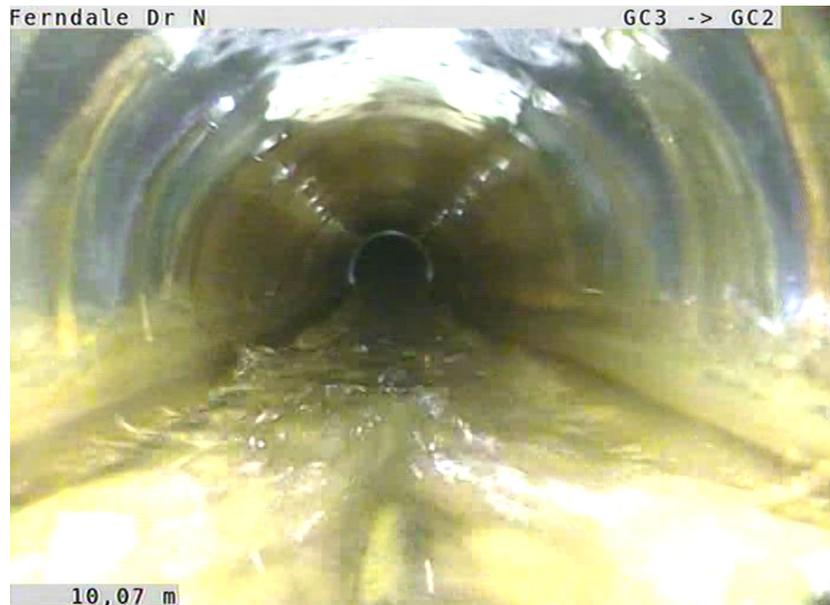
Inspection of the southern half of the groundwater collection gallery between GC4 and GC2 indicated that the pipe is in good condition and no deficiencies; typical conditions were observed, as indicated in Photo 14.

Photo 14: Typical conditions within Gallery between manholes GC3N and GC2.

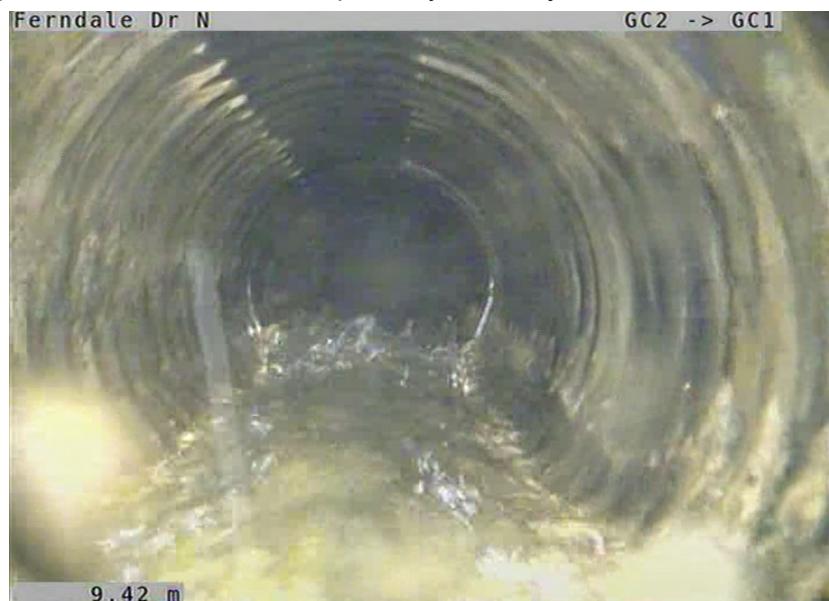
Gallery sections between GC2 and GC1 represent the older section of the Gallery that was constructed in 2002. The inspection along these pipe sections indicates unobstructed flows within the pipe. Clogged perforations at several locations within the first 12 m of this section are observed as shown in Photo 15, similar to the clogging observed between GC4 and GC2 prior to reconstruction. Minimal clogging was observed for the remaining section of the Gallery between GC2 and GC1; typical conditions are represented in Photo 16. This section of the Gallery is furthest from the landfill and progressive clogging is expected have minimal effect on the operation of the Gallery. Future replacement of the Gallery section between GC2 and GC1 is not anticipated. Furthermore it is noted that reconstruction of this part of the Gallery would be problematic as a result of the proximity to the adjacent creek and building.

Photo 15: Typical conditions within Gallery approximately 12m downgradient of GC2 showing clogged perforations

- The entire length of the Gallery was cleaned and inspected. The Gallery was noted to be good condition and unobstructed flows are observed;
- Clogged perforations are observed at several locations within the first 12 m of the Gallery immediately downstream of GC2; this is not expected to materially affect the performance of the Gallery;

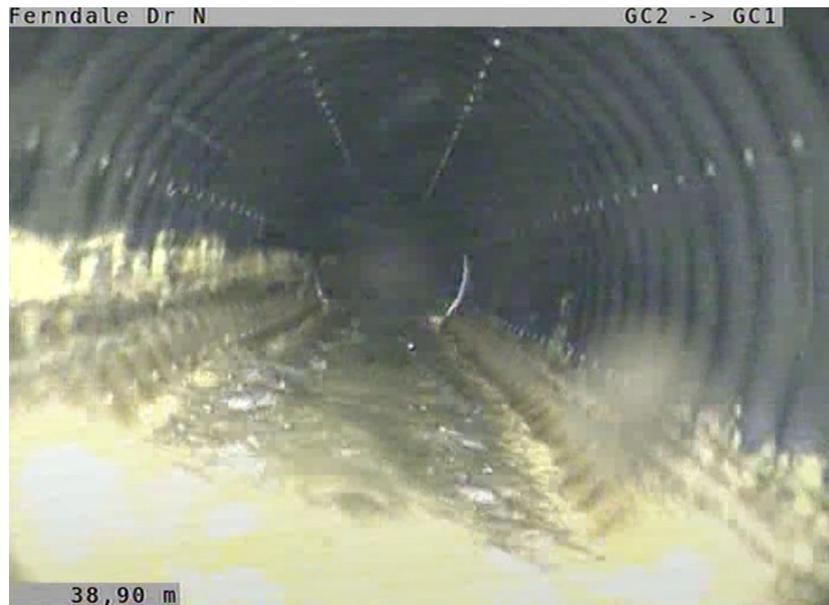
Photo 16: Typical conditions within Gallery between manholes TDMH1 and GC2 following flushing.

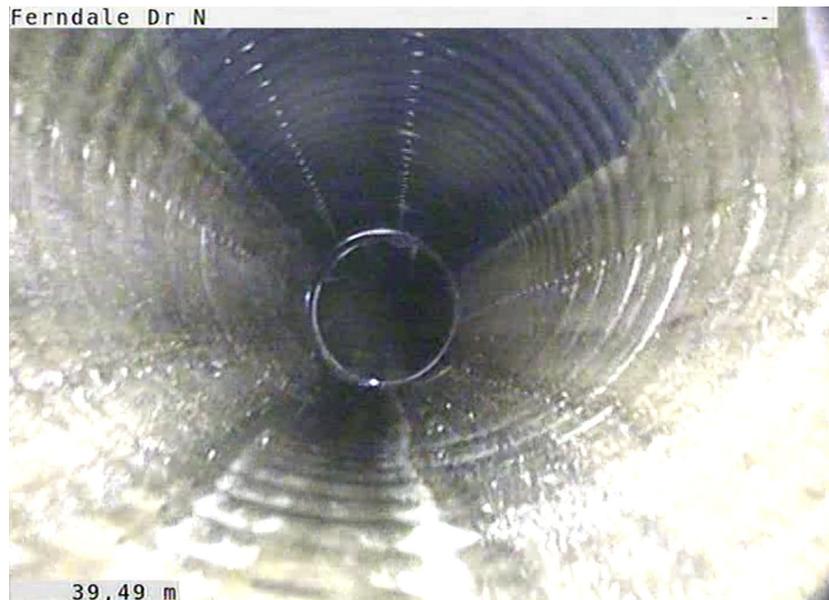
The Gallery Toe Drain section between TDMH2 and GC2 was inspected prior to and following flushing. Inspection of the Toe Drain connection to the Gallery indicated no visible clogging, and typical conditions are represented in Photo 18. Following reconstruction of the Gallery in 2017, minimal flow is observed in the Toe Drain due to the increased effectiveness of the Gallery.

Photo 17: Typical conditions within Gallery between manholes TDMH1 and GC2 following flushing.
