## 2024 Sanitary Collection System Annual Report

Environmental Compliance Approval 014-W601

March 26, 2025

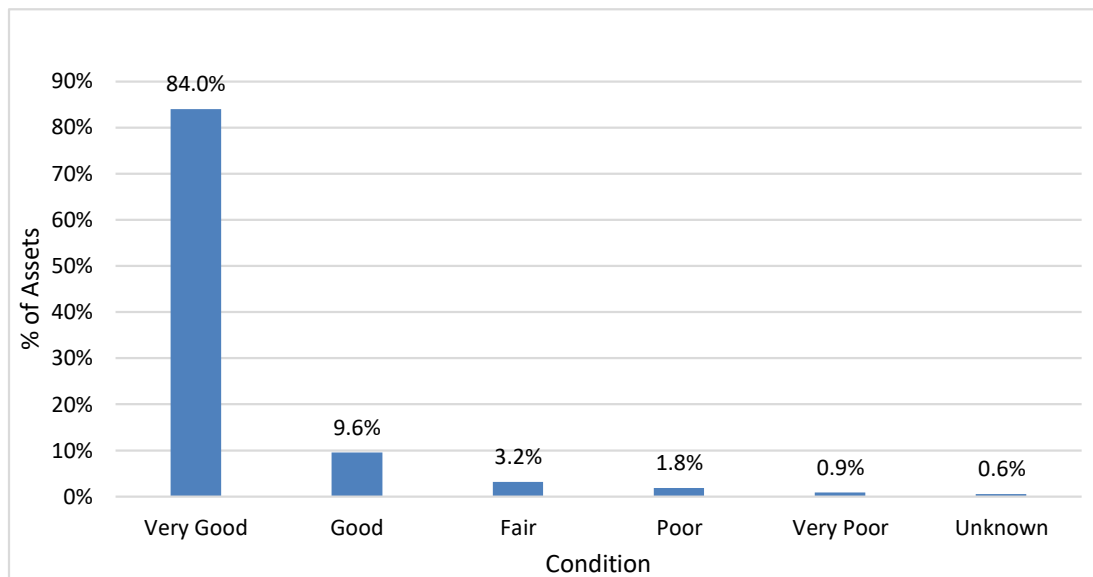
Figure 12 2024 Sanitary Sewer Condition Rating

The City administers a closed-circuit television (CCTV) sewer inspection program for sanitary sewers. The City's contractor conducted inspections on approximately 52 km of sanitary sewers. Please refer to Appendix A for a map of Sanitary Flushing and CCTV. The sanitary mains that were inspected ranged in age from 25 to 50 years old. Despite the age of the pipes, the CCTV results revealed that the pipe conditions were generally rated as very good condition. The use of CCTV technology allows a thorough examination of the sanitary collection system to ensure early and effective detection of any potential issues such as damaged pipes, inflow, infiltration and potential blockages. The information garnered from the CCTV inspections feed into the flushing and insitu repair programs described below. The inspected sewers had an 84% very good condition rating, indicating that the CCTV program has effectively provided staff with information to complete proactive and preventative maintenance within the system. These efforts have preserved the integrity of the pipes, contributing to the overall functionality and longevity of the sanitary collection system. The condition rating of the sanitary sewer collection system in its entirety is shown in the figure below:
