2020 Operations Report, Appendix H - 2020 Leachate Collection System, Purge Well Gravity Drain and Groundwater Gallery Cleaning and Inspection Report

City of Barrie

Golder Associates Ltd.

June 2021

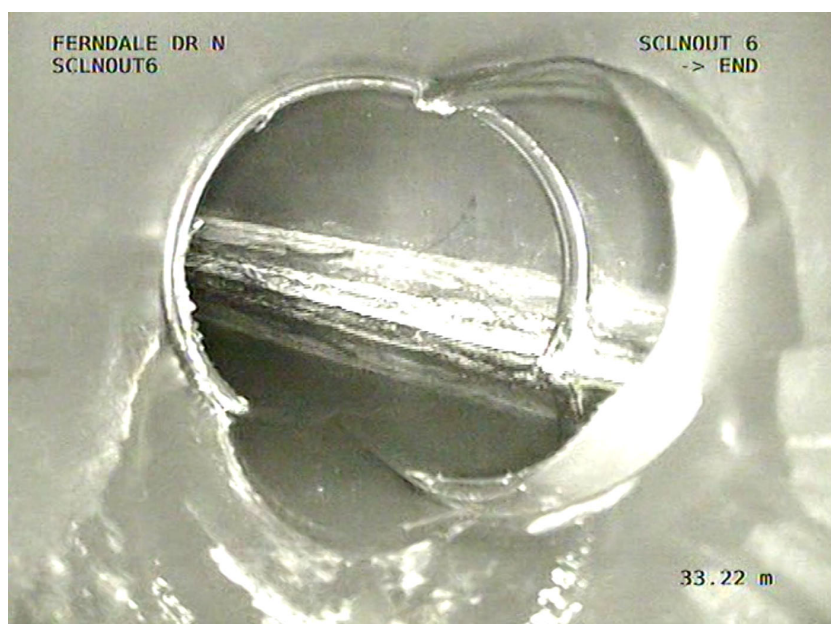
Photo 1: Typical cleanout connection to LCS laterals in Cells 2A and 3A.

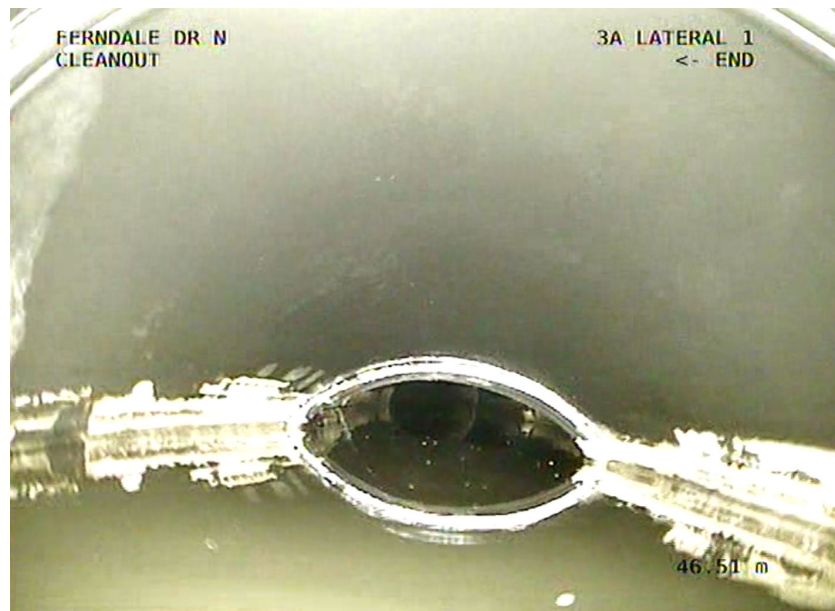
Photo 2 shows the condition within the west cleanout access to 3A Lateral 1 at approximately 47 m from the cleanout entrance. Sumping observed in this area is further supported by the video inspection of the 3A West Header, which also indicates a sump condition, as shown in Photo 3. During the inspection, the camera was able to navigate beyond the sump in the 3A Lateral 1 pipe and the entire length of the lateral was inspected. The inspection indicates that the 3A Lateral 1 is clear and is draining towards the maintenance chamber in Cell 3A; typical 3A Lateral 1 conditions are shown in Photo 4.

Photo 2: Sumping (as observed in 2020) within west cleanout access to 3A Lateral 1 at approximately 47 m.

- The portion of Cells 2A and 3A LCS that can be inspected appears to be in a good condition. Leachate flows appear unobstructed, with the exception of the northern extent of the 3A West Header, where some sumping (a low point in the pipe) is observed causing locally high leachate levels within the LCS;

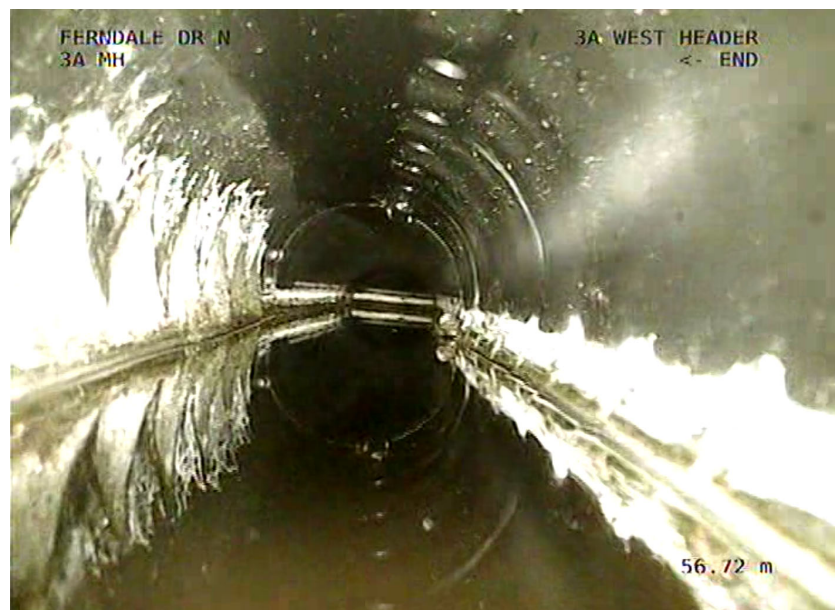
Photo 3: Sumping (as observed in 2020) within 3A West Header at approximately 57 m.

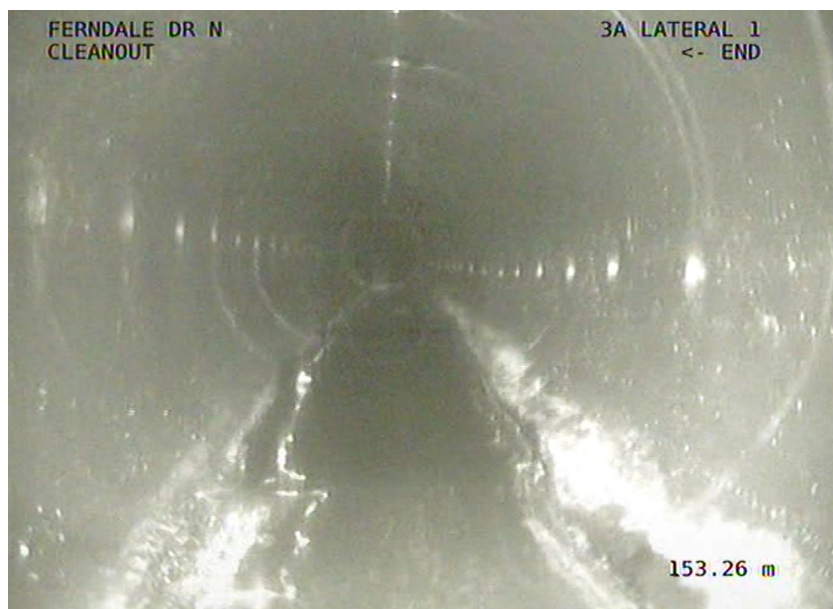
Photo 4: Typical conditions within the 3A Lateral 1.

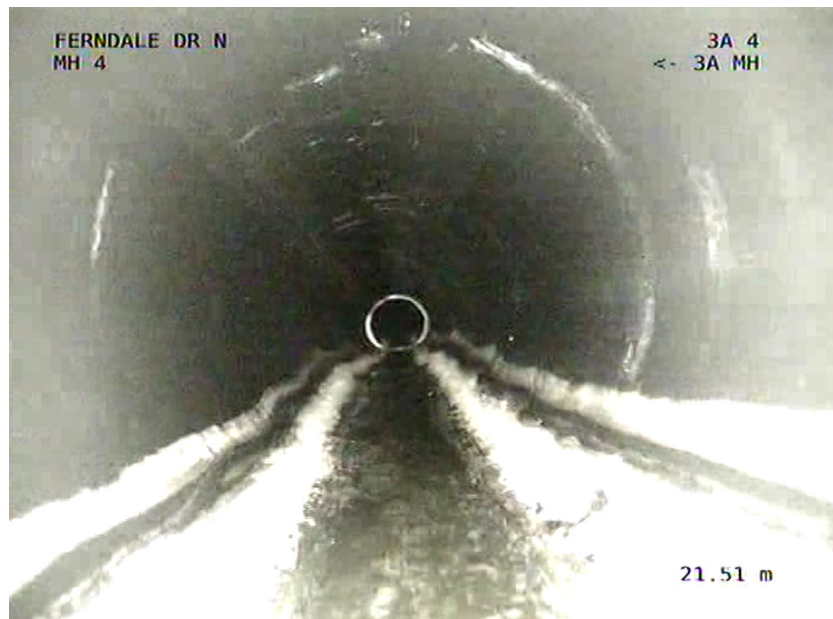
Inspection of the leachate conveyance line between the 3A Maintenance Chamber and MH4 identified small amounts of accumulated sediment / precipitate, which was similarly noted in previous inspection programs (Photo 5).

Photo 5: Leachate conveyance line between 3A maintenance chamber and MH4.

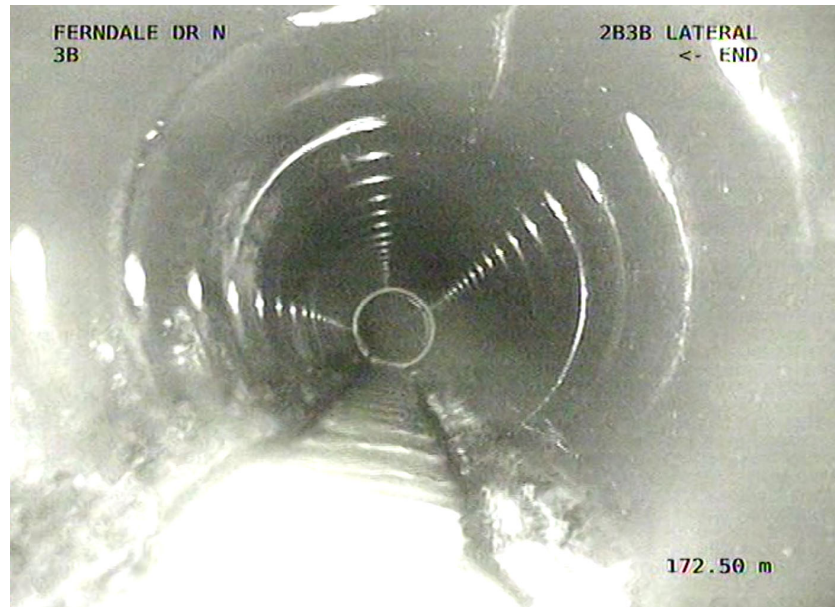
Following cleaning of the 2B / 3B Lateral from the Cell 3B internal maintenance chamber, video inspection was conducted. The lateral was inspected to a length of 205 m, short of the 265 m length of this lateral, as the camera lost traction. Inspection of the lateral indicated that it was in good condition, as shown in Photo 6.

Photo 6: Typical conditions within the 2B / 3B Lateral.

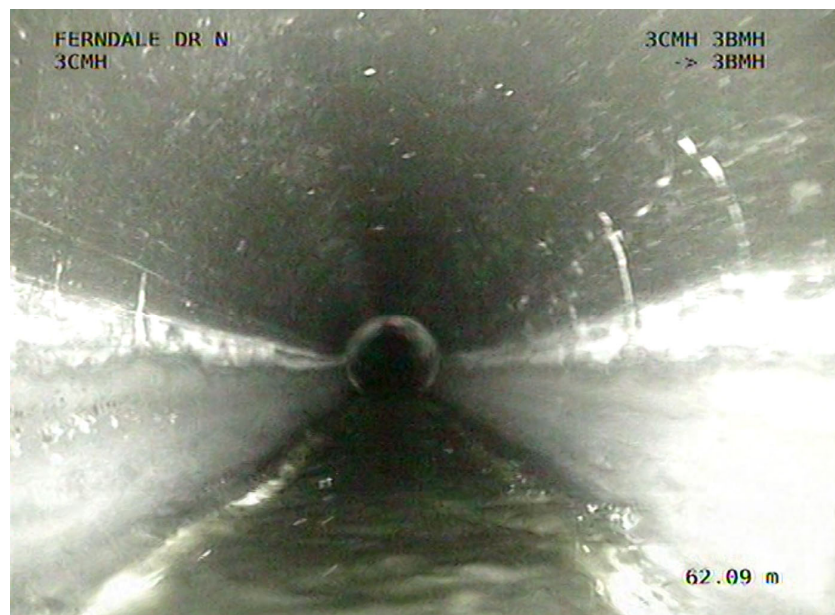
The 3B / 3C West Header was also video inspected and the inspection indicated that the pipe was in good condition (Photo 7). The leachate conveyance pipeline between the Cell 3B internal maintenance chamber and the 3B exterior maintenance chamber was inspected starting at the Cell 3B location and indicated that the LCS was in good condition.

Photo 7: Typical conditions within the 3B / 3C West Header.

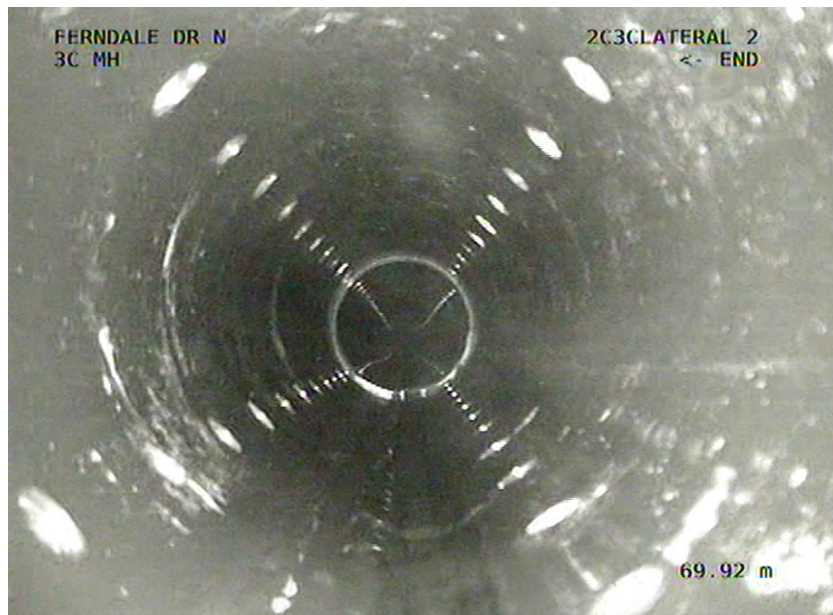
Following cleaning of the 2C / 3C Lateral 1, 2C / 3C Lateral 2 and 2C / 3C Lateral 3, video inspection was conducted. Inspection of the laterals revealed good conditions, as shown in Photos 8 and 9.

Photo 8: Typical conditions within 2C / 3C Lateral 2

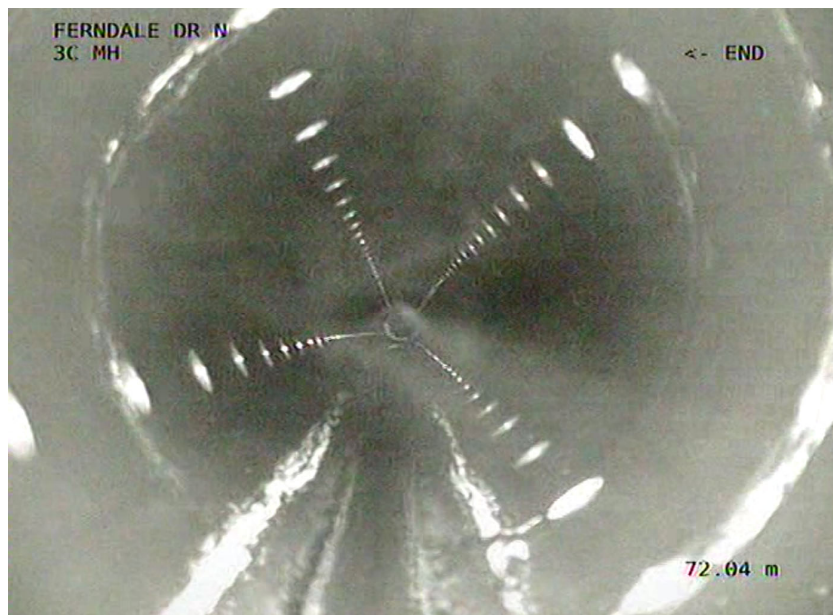
Photo 9: Typical conditions within 2C / 3C Lateral 3

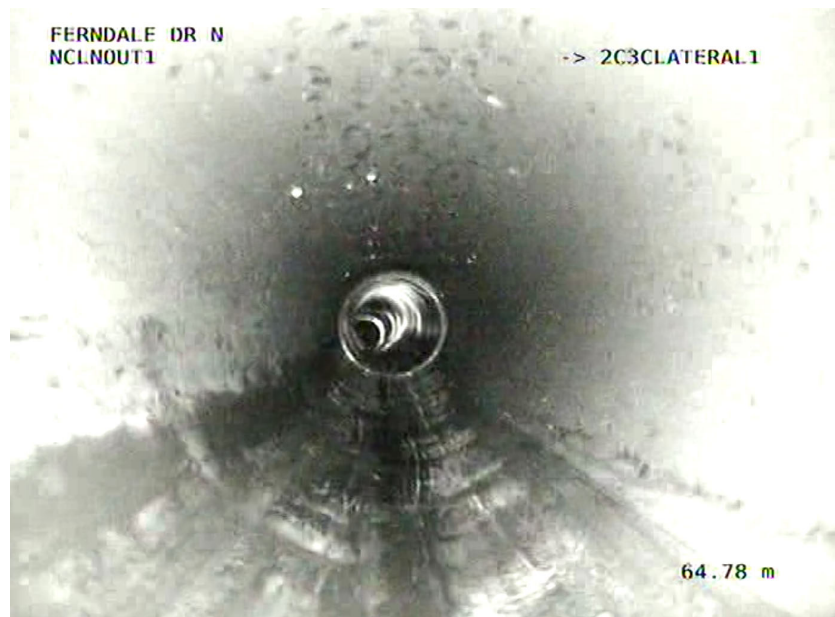
Following cleaning of two cleanouts, NCleanout 1 and NCleanout 2, video inspection was conducted. Inspection of the cleanouts revealed good conditions, as shown in Photo 10.

Photo 10: Typical conditions within NCleanout 1.

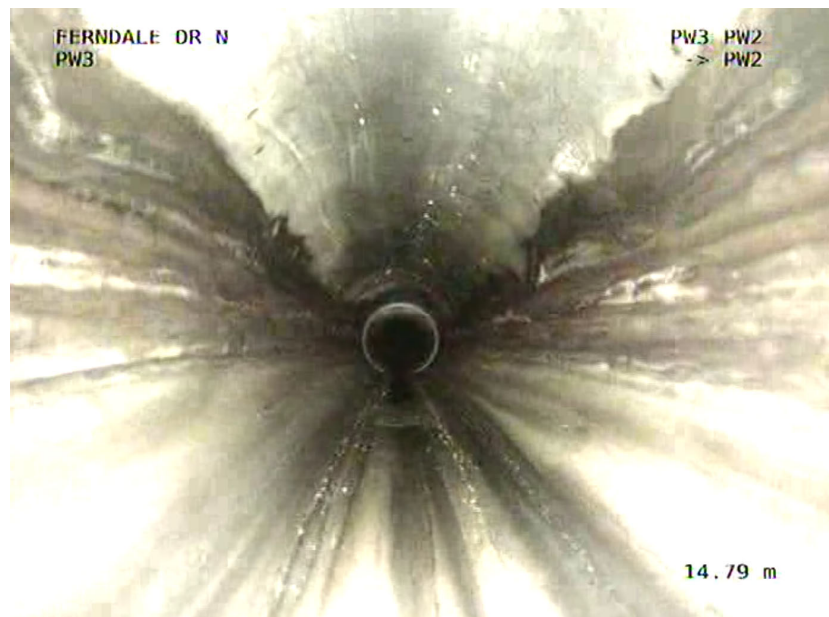
The purge well gravity drain was inspected following the flushing of the pipeline from PW4 to MH4. The purge wells discharging to the system were shut off during inspection of the PW gravity drain. Each section exhibited sidewall staining consistent with high water levels in the pipe during operation. The flushing operation successfully cleaned the pipes of accumulated silt and precipitate. Typical conditions in the purge well gravity drain can be seen in Photo 11.

Photo 11: Purge well main condition, approximately 15 m downstream of PW3.

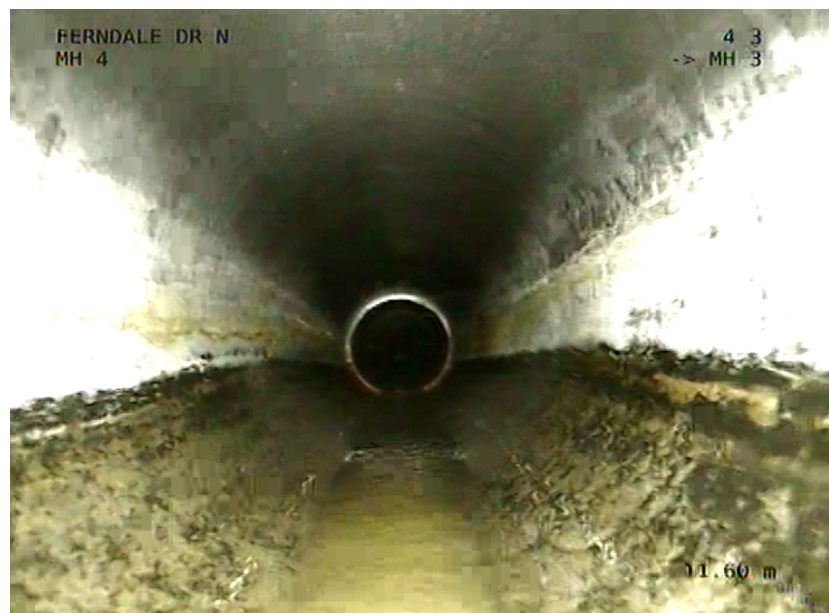
The LCS/PW gravity drain was video inspected sequentially, from MH4 through to MHA, MHB and MHC, and indicated that the pipe was in good condition (Photo 12).

Photo 12: LCS/PW gravity drain condition after flushing, approximately 12 m downstream of MH4.

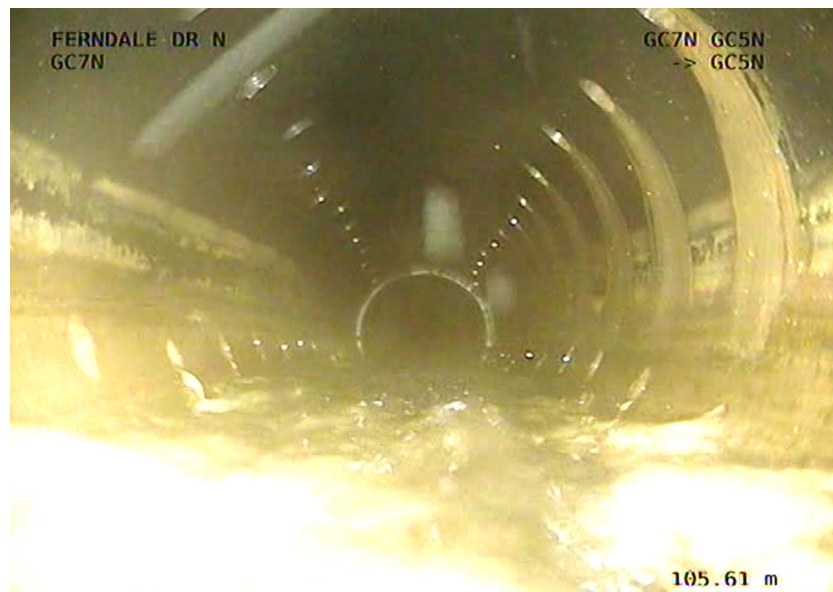
In 2020, the Gallery was inspected following flushing of the Gallery from GC7N to GC1. Based on previous inspection programs, it was anticipated the thickest accumulation of precipitate would be observed in the section between GC7N and GC5N. Although the precipitation in this section was thick, it was soft and appeared to have been completely removed following flushing, as shown in Photo 13.

Photo 13: Typical conditions within Gallery between manholes GC7N and GC5N following flushing.

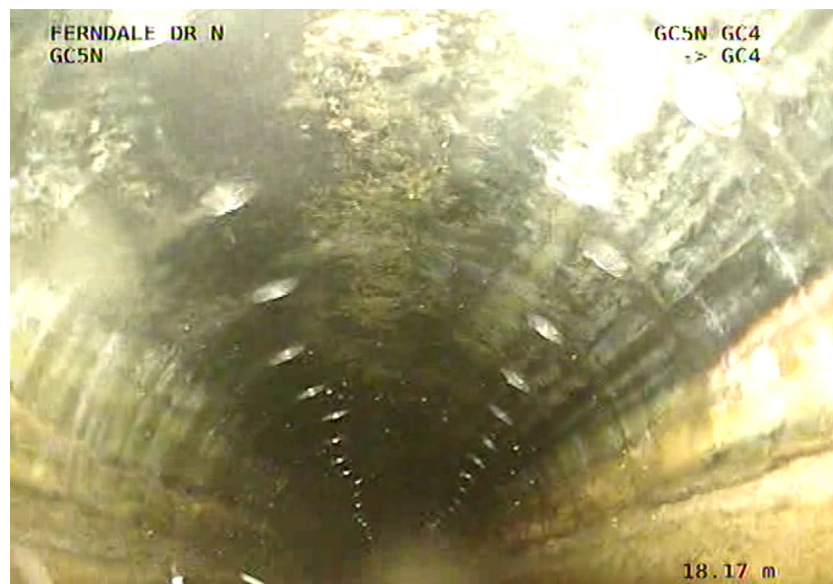
The Gallery section between GC5N and GC4 was inspected following flushing and indicated that this pipe section was in good condition, as shown in Photo 14. A video still of a perforation in the Gallery collection pipe is shown in Photo 15. This photo indicates that there was no visible clogging. This condition is considered to represent typical conditions in the Gallery between manholes GC7N and GC4.

Photo 14: Typical conditions within Gallery between manholes GC5N and GC4 following flushing.

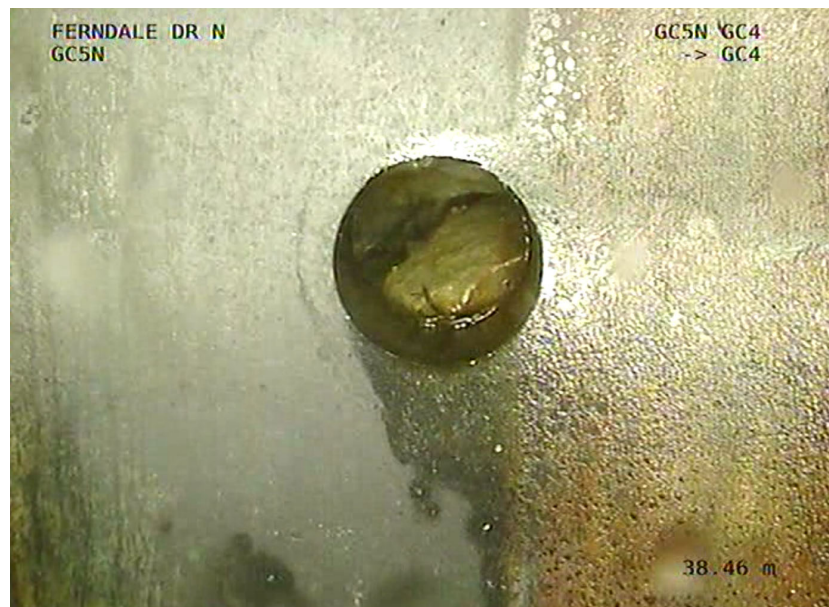
Photo 15: Perforations in the sidewall of the Gallery collector pipe between GC5N and GC4.

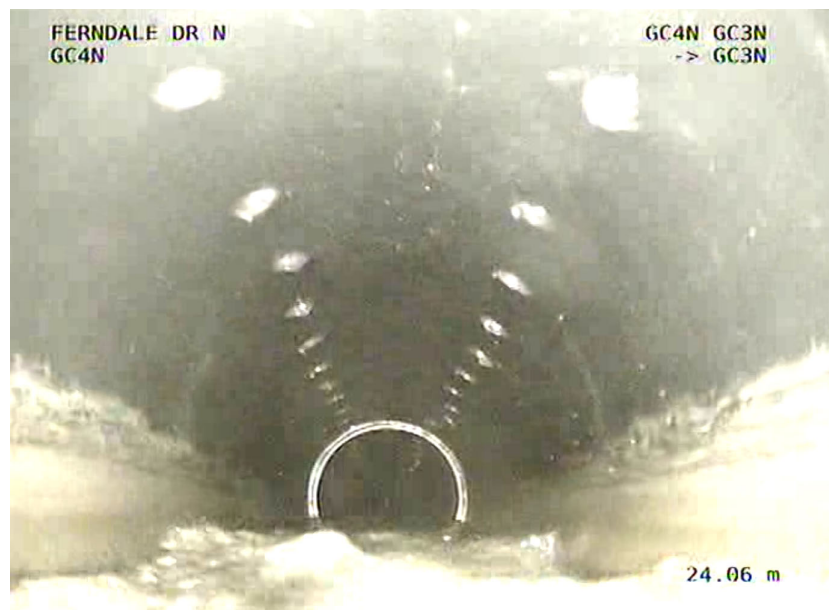
Inspection of the southern half of the groundwater collection gallery between GC4 and GC2 indicated that the pipe is in good condition and no deficiencies were noted; typical conditions were observed, as indicated in Photo 16.

Photo 16: Typical conditions within Gallery between manholes GC4N and GC3N.

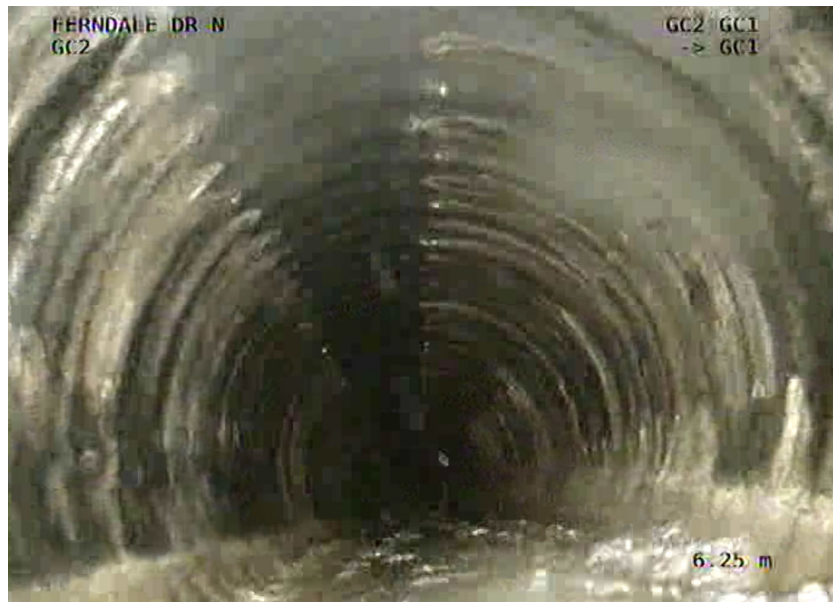
Photo 17: Typical conditions within Gallery approximately 12m downgradient of GC2 showing clogged perforations

- The entire length of the Gallery was cleaned and inspected. The Gallery was noted to be in good condition and unobstructed flows were observed;
- Clogged perforations were observed at several locations within the first 12 m of the Gallery immediately downstream of GC2. The extent of clogging appears relatively unchanged in recent years and is not expected to materially affect the performance of the Gallery;

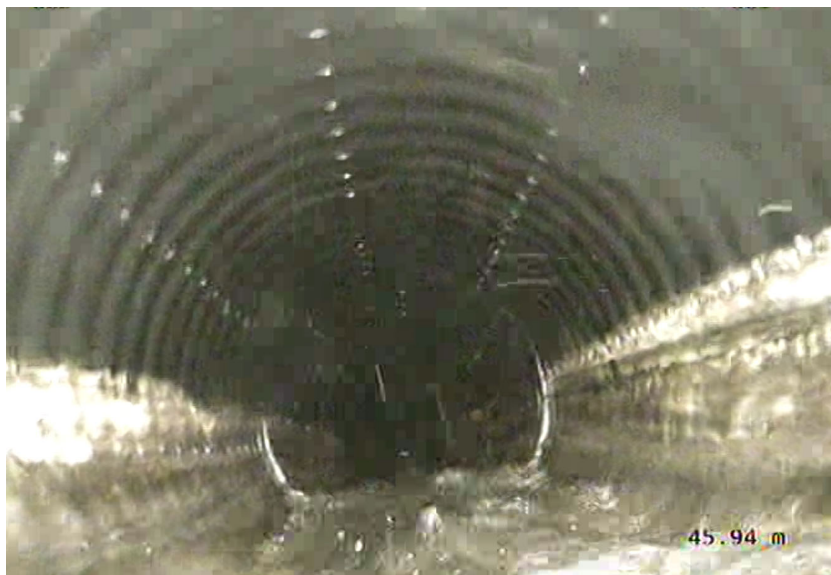
GC1; typical conditions are represented in Photo 18. This section of the Gallery is furthest from the landfill and progressive clogging is expected to have minimal effect on the operation of the Gallery. Future replacement of the Gallery section between GC2 and GC1 is not considered to be required at this time. Furthermore, it is noted that reconstruction of this part of the Gallery would be problematic as a result of the proximity to the adjacent creek and building housing the flow recording equipment. In previous years, gravel and other debris was noted to have built-up at the base of GC1 following flushing of the Gallery; this build-up material was removed in previous years but was not present in 2020. It is recommended the potential build-up of material at GC1 as a result of flushing operations be evaluated each year, and this material should be removed as required using the vacuum truck.

Photo 18: Typical conditions within Gallery between manholes GC2 and GC1 following flushing.

- Continued annual flushing and inspection of the LCS, Gallery, PW Gravity drain and landfill Gravity drain should be conducted.
- It is recommended the potential build-up of material at GC1 as a result of flushing operations be evaluated each year and removed as required using the vacuum truck.

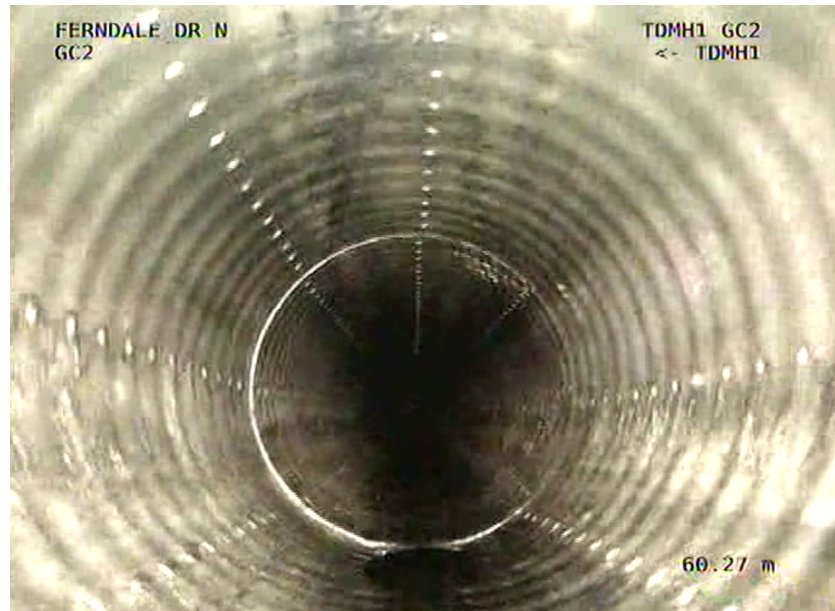
The Gallery Toe-Drain sections between TDMH2 and TDMH1 and between TDMH1 and GC2 were inspected prior to and following flushing. Inspection of the Toe-Drain connection to the Gallery indicated no visible clogging, and typical conditions are represented in Photo 19. Following reconstruction of the Gallery in 2017, minimal flow is observed in the Toe-Drain due to the increased effectiveness of the Gallery.

Photo 19: Typical conditions within Gallery between manholes TDMH1 and GC2 following flushing.
