**TO:** GENERAL COMMITTEE

**SUBJECT:** SAM CANCELLA PARK GAZEBO REHABILITATION

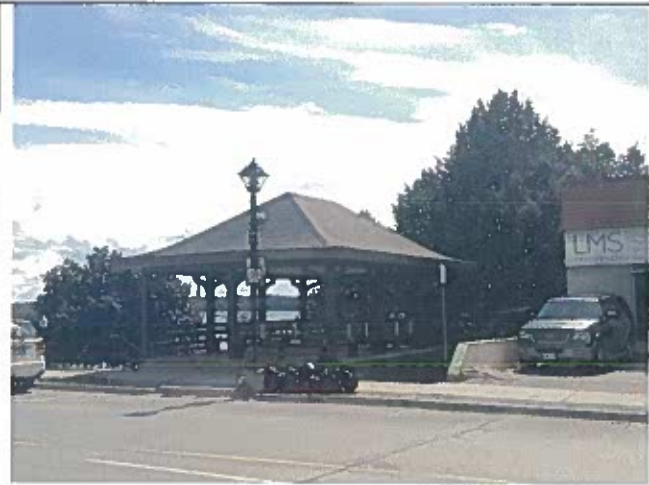
**Photo #1:** Front view of Sam Cancilla Park Gazebo

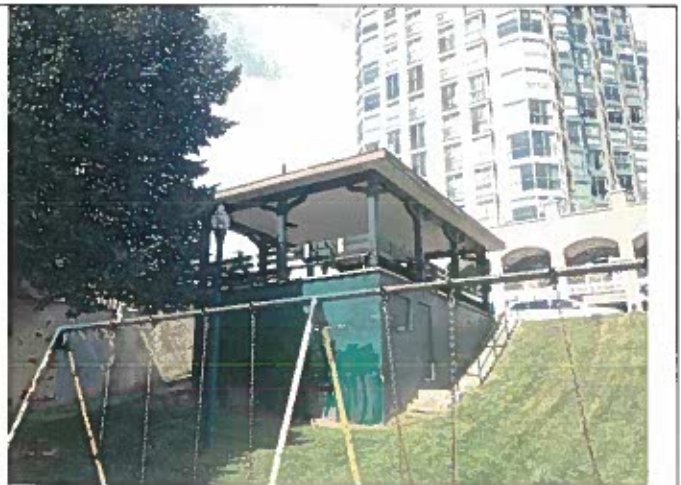
**Photo #2:** Rear view of Sam Cancilla Park Gazebo

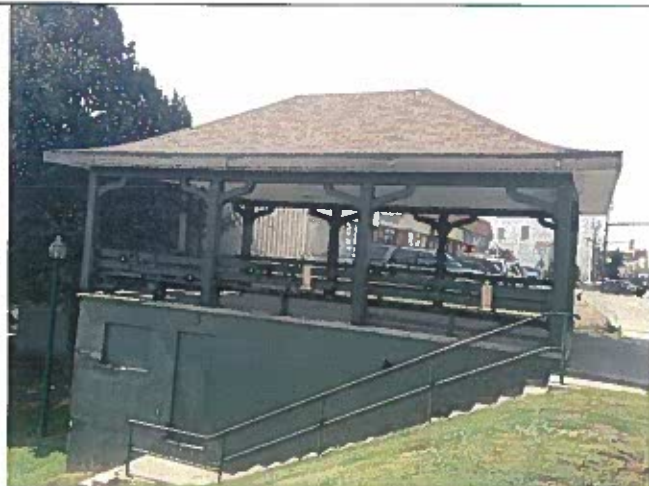
**Photo #3:** East view of Sam Cancilla Park Gazebo

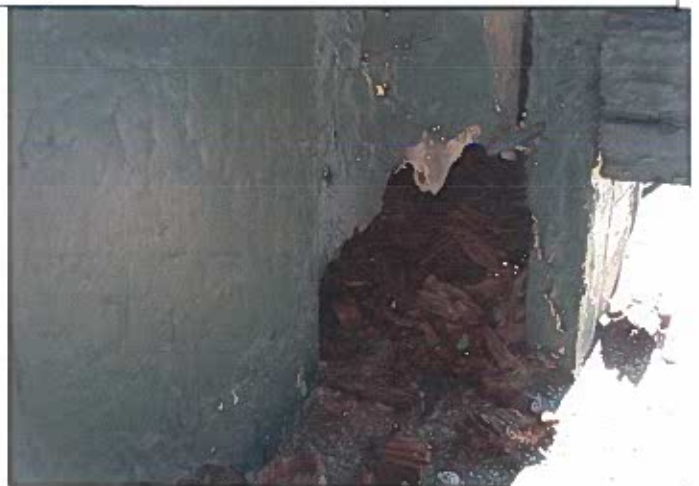
- c) All wood posts are experiencing varying degrees of wood rot, which is especially prevalent at the base. In two cases, the rot has penetrated approximately half-way up the post from the bottom; and,

**Photo #4:** View of base of rotted post.

7. Included within the Structural Report were 3 minimum recommendations provided by the Structural Engineer, as follows:
  - a) Proceed with the replacement of all posts, provide guards, and remove benches
