2019 Operations Report, Appendix H - 2019 Leachate Collection System, Purge Well Gravity Drain and Groundwater Gallery Cleaning and Inspection Report

City of Barrie

Golder Associates Ltd.

June 2020

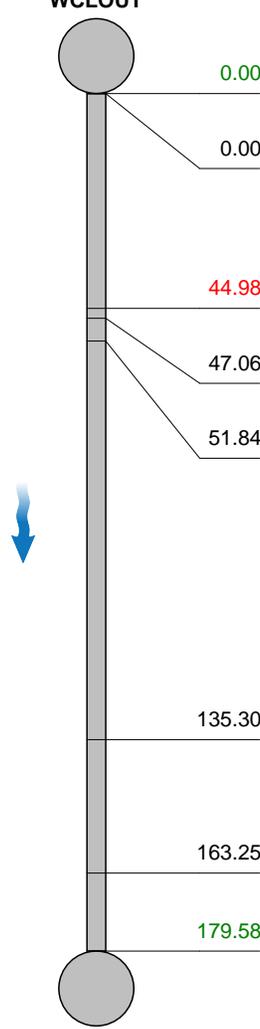
0.00	ACOM	Cleanout Mainline / WCLOUT	00:00:00			
	0.00	MWL	Water Level, 0% of cross sectional area	00:00:25			
	44.98	D	Deformed, 5% changed	00:03:28		S4	
	47.06	MWL	Water Level, 95% of cross sectional area	00:03:44			
	51.84	MWL	Water Level, 50% of cross sectional area	00:04:17			
	135.30	MGP	General Photograph	00:09:34			
	163.25	MGP	General Photograph	00:11:53			
	179.58	AEP	End of Pipe / Capped	00:12:34			
	3A Lateral 1

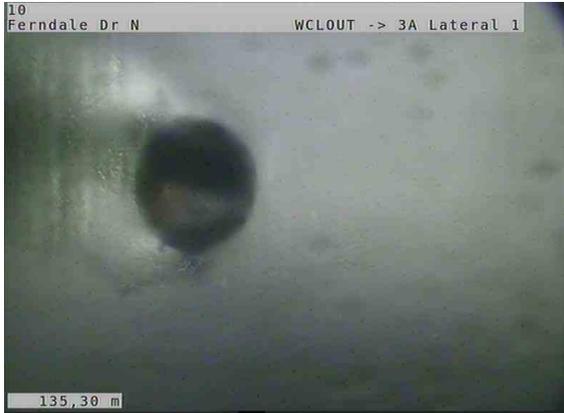
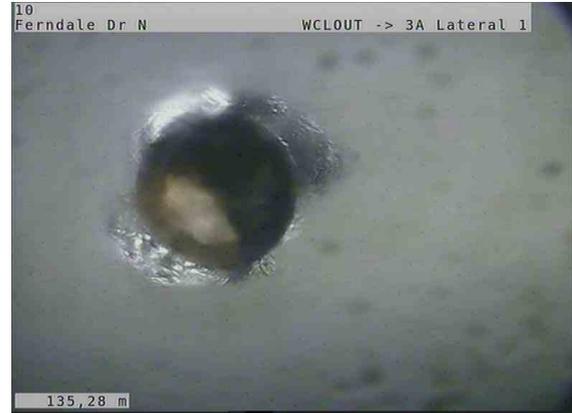
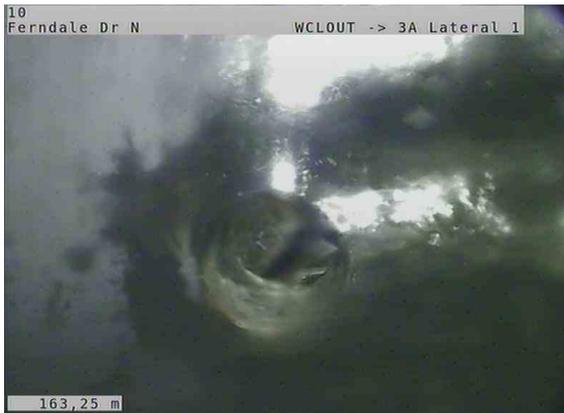
City Barrie	Street Ferndale Dr N	Date 2019-09-17	Pipe Segment WCL0UT-3ALateral1	Nr. 10
-----------------------	--------------------------------	---------------------------	--	------------------

, 00:09:34, 135.30
General Photograph

, 00:11:53, 163.25
General Photograph

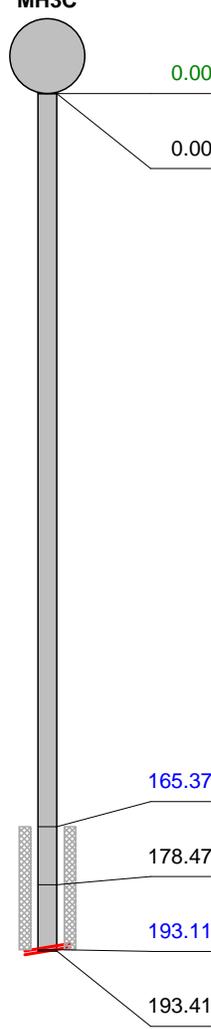
0.00	AMH	Manhole / MH3C	00:00:00		
	0.00	MWL	Water Level, 20% of cross sectional area	00:00:24		
	165.37	S01 DSF	Deposits Settled Fine, 10% of cross sectional area from 5 o'clock to 7 o'clock, Start	00:11:39		
	178.47	MGP	General Photograph	00:12:51		
	193.11	F01 DSF	Deposits Settled Fine, 10% of cross sectional area from 5 o'clock to 7 o'clock, Finish	00:18:00		M2
	193.41	MSA	Survey Abandoned / Unable to pass DSF	00:18:02		
QSR	QMR	SPR	MPR	OPR	SPRI	MPRI
0000	2600	0.0	12.0	12.0	0.0	2.0

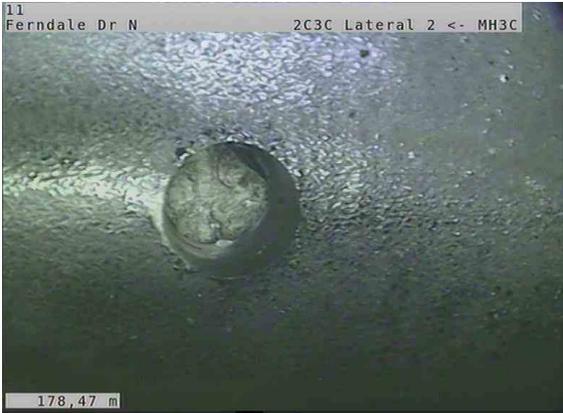
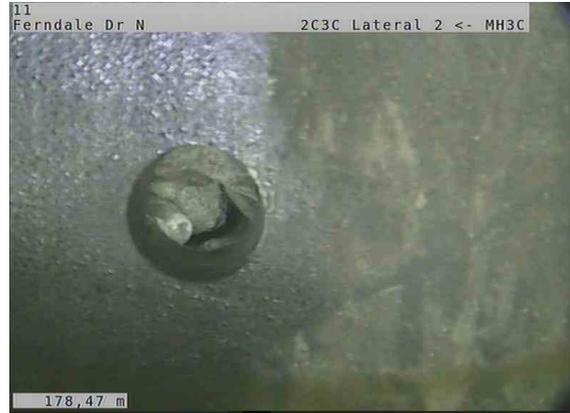
City Barrie	Street Ferndale Dr N	Date 2019-09-17	Pipe Segment MH3C-2C3CLateral2	Nr. 11
-----------------------	--------------------------------	---------------------------	--	------------------

, 00:12:51, 178.47
General Photograph

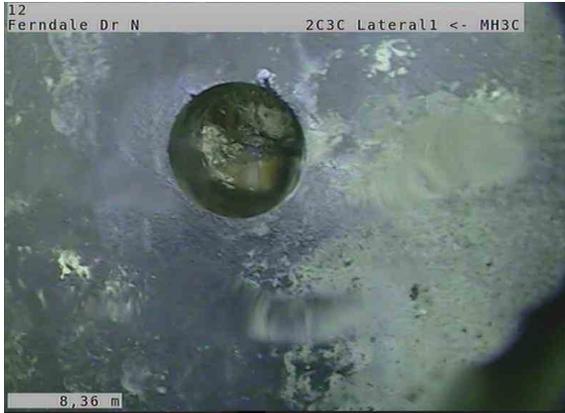
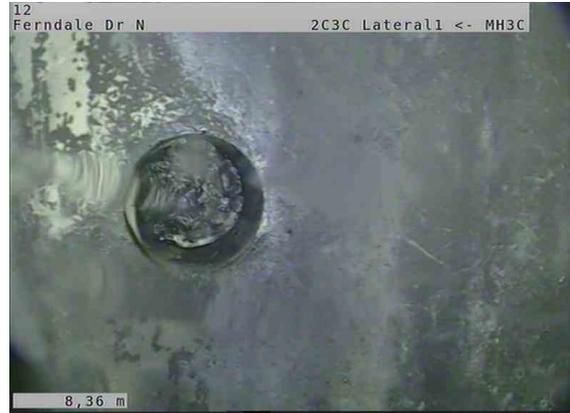
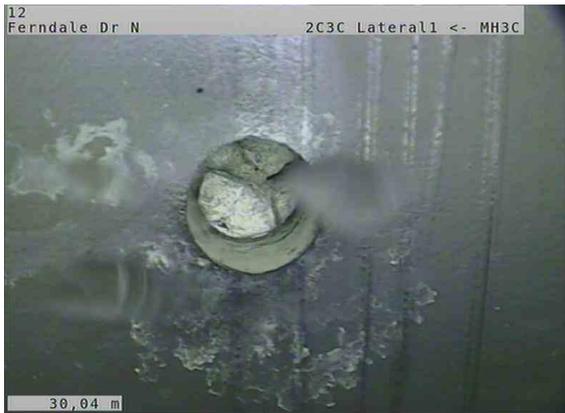
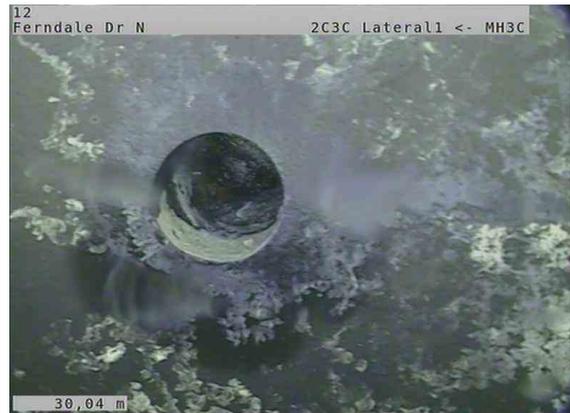
City Barrie	Street Ferndale Dr N	Date 2019-09-18	Pipe Segment MH3C-2C3CLateral1	Nr. 12
-----------------------	--------------------------------	---------------------------	--	------------------

, 00:01:21, 8.36
General Photograph

, 00:03:10, 30.04
General Photograph

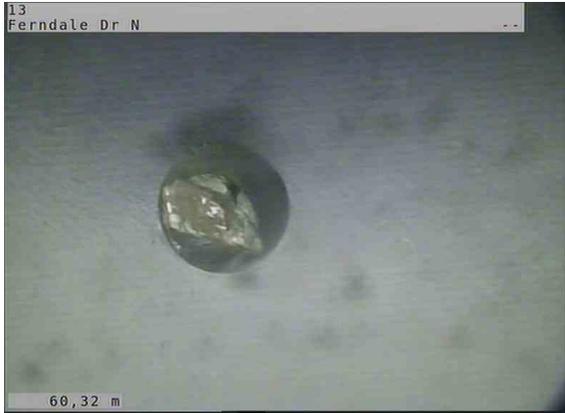
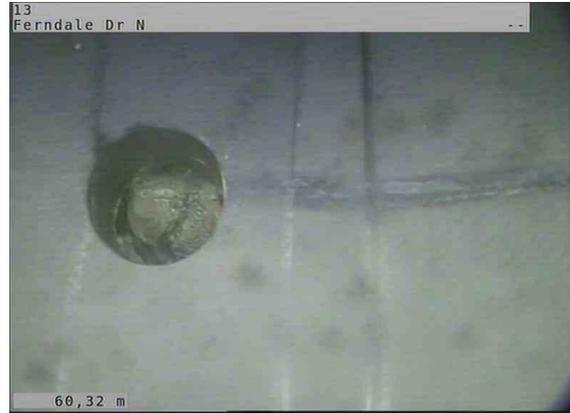
City Barrie	Street Ferndale Dr N	Date 2019-09-18	Pipe Segment MH3C-2C3CLateral3	Nr. 13
-----------------------	--------------------------------	---------------------------	--	------------------

, 00:05:04, 60.32
General Photograph

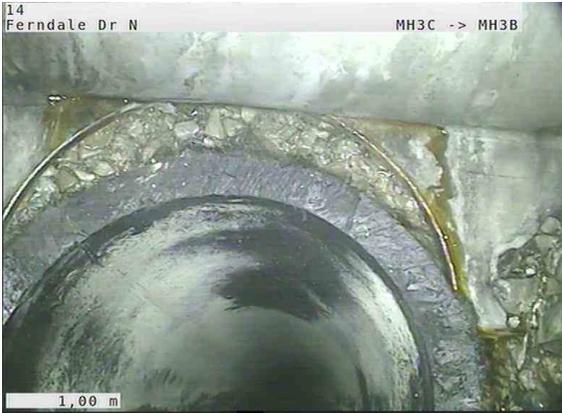
City Barrie	Street Ferndale Dr N	Date 2019-09-18	Pipe Segment 3B3CWestheader	Nr. 14
-----------------------	--------------------------------	---------------------------	---------------------------------------	------------------

, 00:00:42, 1.00
General Photograph / Inlet offset

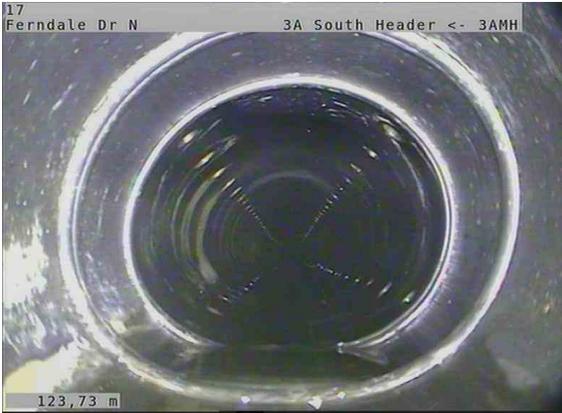
City Barrie	Street Ferndale Dr N	Date 2019-09-18	Pipe Segment 3AMH-3ASouthHeader	Nr. 17
-----------------------	--------------------------------	---------------------------	---	------------------

, 00:10:54, 123.72
Deformed, 5% changed

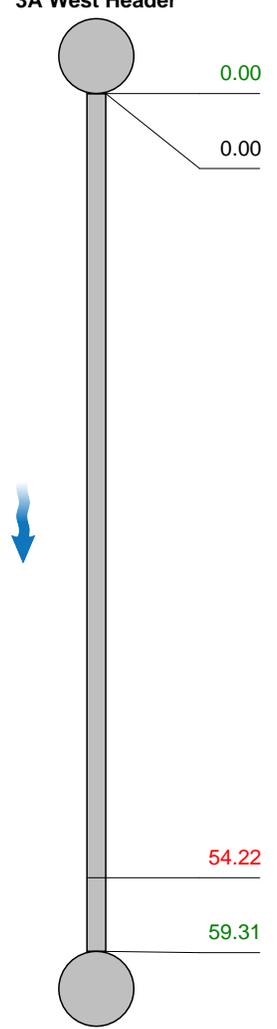
Photo 2 shows the condition within the west cleanout access to 3A Lateral 1 at approximately 47 m from the cleanout entrance. Sumping observed in this area is further supported by the video inspection of the 3A West Header, which also indicates a sump condition, as shown in Photo 3. During the inspection, the camera was able to navigate beyond the sump in the 3A Lateral 1 pipe and the entire length of the lateral was inspected. The inspection indicates that the 3A Lateral 1 is not plugged and is draining towards the maintenance chamber in Cell 3A; typical 3A Lateral 1 conditions are shown in Photo 4.

Photo 3: Sumping (as observed in 2019) within 3A West Header at approximately 59 m.

- The portion of Cell 2A and 3A LCS that can be inspected appears to be in a good condition. Leachate flows appear unobstructed, with the exception of the northern extent of the 3A West Header where some sumping (a low point in the pipe) is observed, causing locally high leachate levels within the LCS;

1:518	Distance	Code	Observation	Counter	Photo	Grade
3A West Header						
	0.00	AMH	Manhole / 3AMH	00:00:15		
	0.00	MWL	Water Level, 5% of cross sectional area	00:00:23		
	54.22	D	Deformed, 5% changed	00:05:13		S4
	59.31	AEP	End of Pipe / 3A Lateral 1	00:05:43		
			3AMH

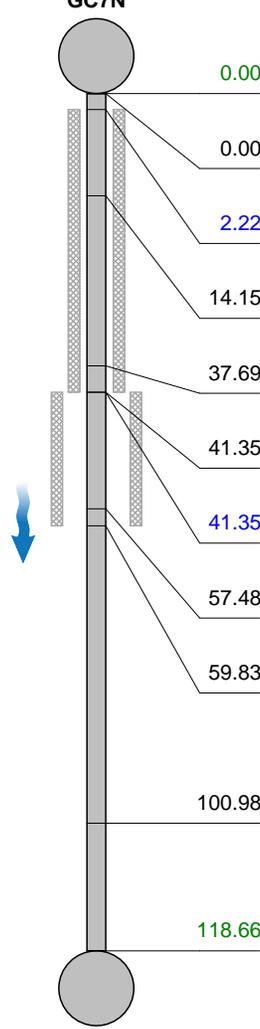
1:1037	Distance	Code	Observation	Counter	Photo	Grade
GC7N

0.00	AMH	Manhole / GC7	00:00:00		
	0.00	MWL	Water Level, 10% of cross sectional area	00:00:00		
	2.22	S01	DAE Deposits Attached Encrustation, 5% of cross sectional area from 7 o'clock to 5 o'clock, within 200 mm, Start	00:00:51		
	14.15	MWL	Water Level, 20% of cross sectional area	00:01:56		
	37.69	MWL	Water Level, 40% of cross sectional area	00:04:03		
	41.35	S02	MCU Camera Underwater, Start	00:04:21		
	41.35	F01	DAE Deposits Attached Encrustation, 5% of cross sectional area from 7 o'clock to 5 o'clock, within 200 mm, Finish	00:04:23		M2
	57.48	MWL	Water Level, 10% of cross sectional area	00:05:34		
	59.83	F02	MCU Camera Underwater, Finish	00:05:57		M4
	100.98	MWL	Water Level, 30% of cross sectional area	00:09:48		
	118.66	AMH	Manhole / GC5	00:11:31		
GC5N

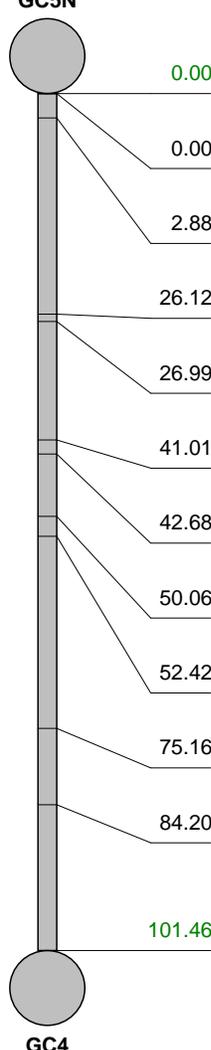
1:887	Distance	Code	Observation	Counter	Photo	Grade
GC5N

0.00	AMH	Manhole / GC5N	00:00:23		
	0.00	MWL	Water Level, 30% of cross sectional area	00:00:26		
	2.88	MWL	Water Level, 10% of cross sectional area	00:00:52		
	26.12	MWL	Water Level, 45% of cross sectional area	00:02:50		
	26.99	MWL	Water Level, 15% of cross sectional area	00:02:54		
	41.01	MWLS	Water Level, Sag in pipe, 40% of cross sectional area	00:04:01		S3
	42.68	MWL	Water Level, 15% of cross sectional area	00:04:09		
	50.06	MWL	Water Level, 45% of cross sectional area	00:04:44		
	52.42	MWL	Water Level, 15% of cross sectional area	00:04:57		
	75.16	MWL	Water Level, 30% of cross sectional area	00:06:50		
	84.20	MWL	Water Level, 10% of cross sectional area	00:08:02		
	101.46	AMH	Manhole / GC4	00:09:23		
GC4

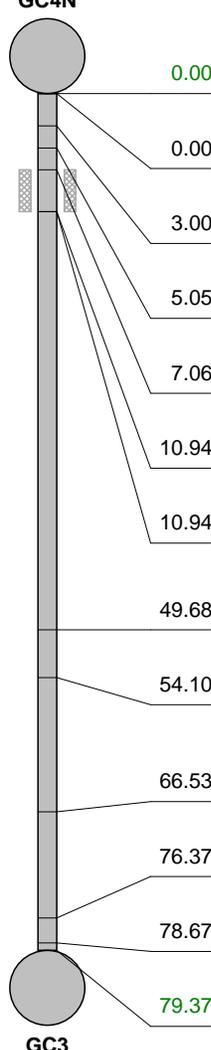
1:694	Distance	Code	Observation	Counter	Photo	Grade
GC4N

0.00	AMH	Manhole / GC4N	00:00:09		
	0.00	MWL	Water Level, 10% of cross sectional area	00:00:18		
	3.00	MWL	Water Level, 35% of cross sectional area	00:00:46		
	5.05	MWL	Water Level, 90% of cross sectional area	00:00:58		
	7.06	S01 MCU	Camera Underwater, Start	00:01:11		
	10.94	F01 MCU	Camera Underwater, Finish	00:01:31		M4
	10.94	MWL	Water Level, 20% of cross sectional area	00:01:34		
	49.68	MWL	Water Level, 60% of cross sectional area	00:04:11		
	54.10	MCU	Camera Underwater	00:04:50		M4
	66.53	MWL	Water Level, 15% of cross sectional area	00:06:12		
	76.37	MWL	Water Level, 50% of cross sectional area	00:07:07		
	78.67	MWL	Water Level, 10% of cross sectional area	00:07:27		
	79.37	AMH	Manhole / GC3	00:07:34		
GC3						
QSR	QMR	SPR	MPR	OPR	SPRI	MPRI
0000	4200	0.0	8.0	8.0	0.0	4.0

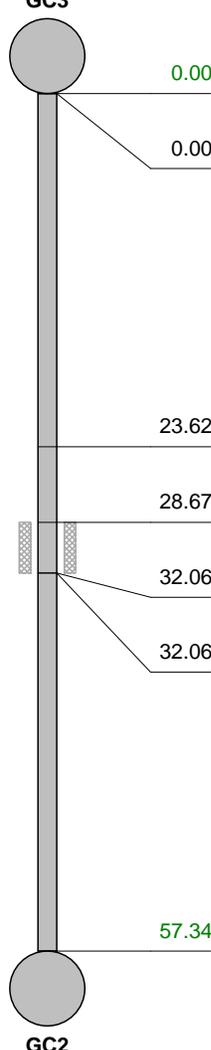
1:501	Distance	Code	Observation	Counter	Photo	Grade
GC3

0.00	AMH	Manhole / GC3	00:00:00		
	0.00	MWL	Water Level, 15% of cross sectional area	00:00:17		
	23.62	MWL	Water Level, 80% of cross sectional area	00:02:04		
	28.67	S01	MCU	Camera Underwater, Start	00:02:12	
	32.06	F01	MCU	Camera Underwater, Finish	00:02:29	M4
	32.06	MWL	Water Level, 25% of cross sectional area	00:02:31		
	57.34	AMH	Manhole / GC2	00:04:26		
GC2
