2020 Operations Report, Appendix H - 2020 Leachate Collection System, Purge Well Gravity Drain and Groundwater Gallery Cleaning and Inspection Report

City of Barrie

Golder Associates Ltd.

June 2021

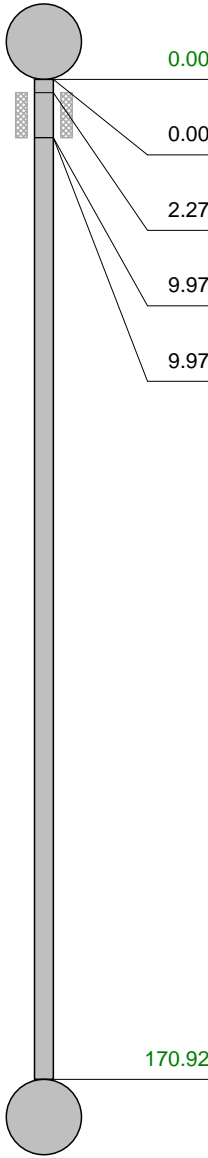
0.00	AMH	Manhole / 3C MH	00:00:09		
	0.00	MWL	Water Level, 100% of cross sectional area	00:00:10		
	2.27	S01	MCU	Camera Underwater, Start	00:00:22	
	9.97	F01	MCU	Camera Underwater, Finish	00:01:01	M4
	9.97	MWL	Water Level, 25% of cross sectional area	00:01:02		
	170.92	AEP	End of Pipe / END	00:20:16		
QSR	QMR	SPR	MPR	OPR	SPRI	MPRI
0000	4200	0.0	8.0	8.0	0.0	4.0

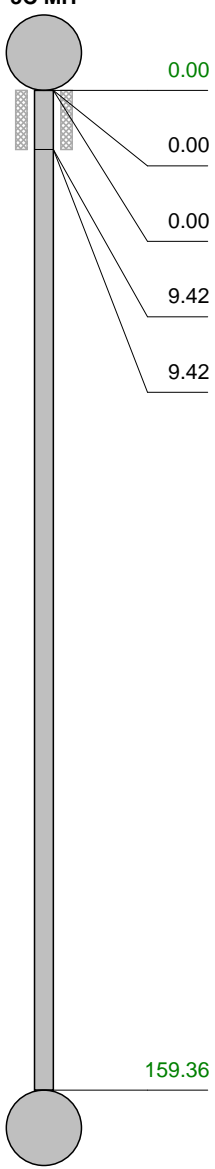
0.00	AMH	Manhole / 3CMH	00:00:08		
	0.00	MWL	Water Level, 100% of cross sectional area	00:00:09		
	0.00	S01	MCU	Camera Underwater, Start	00:00:09	
	9.42	F01	MCU	Camera Underwater, Finish	00:01:09	M4
	9.42	MWL	Water Level, 25% of cross sectional area	00:01:10		
	159.36	AEP	End of Pipe / CAN'T PULL ANY FURTHER	00:32:54		
END						
QSR	QMR	SPR	MPR	OPR	SPRI	MPRI
0000	4200	0.0	8.0	8.0	0.0	4.0

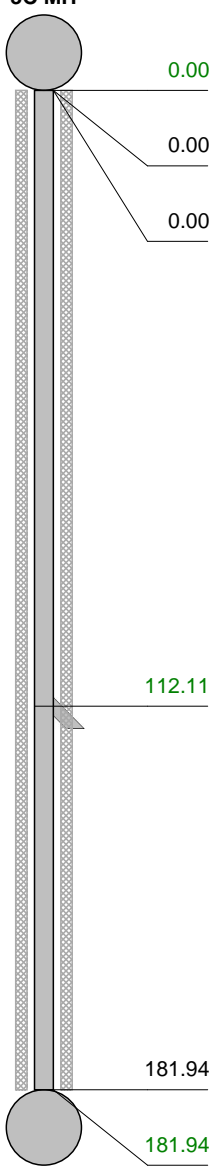
0.00	AMH	Manhole / 3CMH	00:00:12		
	0.00	MWL	Water Level, 100% of cross sectional area	00:00:12		
	0.00 S01	MCU	Camera Underwater, Start	00:00:15		
	112.11	TF	Tap Factory Made at 9 o'clock, 175mm dim	00:19:58		
	181.94 F01	MCU	Camera Underwater, Finish	00:43:10		M4
	181.94	AEP	End of Pipe / END	00:43:11		
END						
QSR	QMR	SPR	MPR	OPR	SPRI	MPRI
0000	4F00	0.0	144.0	144.0	0.0	4.0

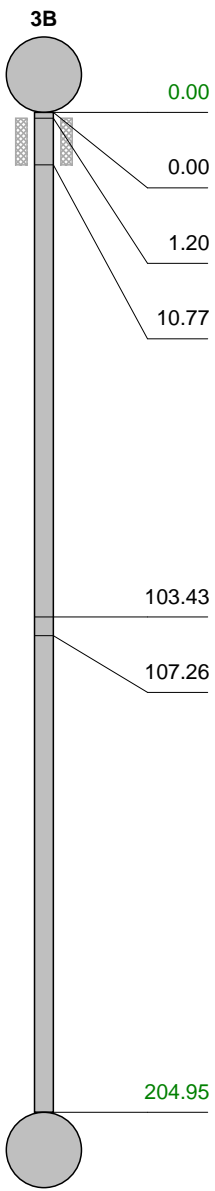
0.00	AMH	Manhole / 3B	00:00:11		
	0.00	MWL	Water Level, 40% of cross sectional area	00:00:11		
	1.20 S01	MCU	Camera Underwater, Start	00:00:26		
	10.77 F01	MCU	Camera Underwater, Finish	00:01:19		M4
	103.43	MWL	Water Level, 40% of cross sectional area	00:12:28		
	107.26	MWL	Water Level, 5% of cross sectional area	00:12:54		
	204.95	AEP	End of Pipe	00:33:15		
END

QSR	QMR	SPR	MPR	OPR	SPRI	MPRI	OPRI
0000	4200	0.0	8.0	8.0	0.0	4.0	4.0

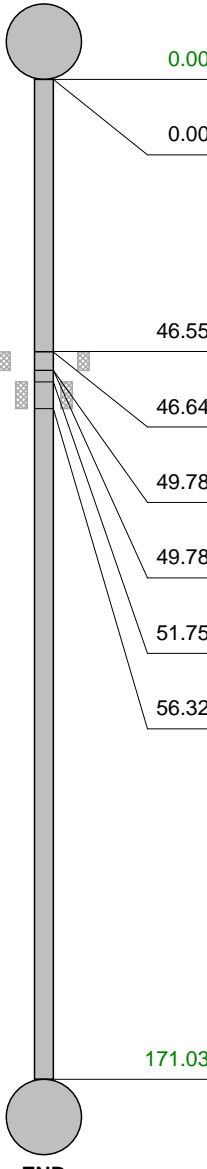
0.00	ACOM	Cleanout Mainline / CLEAN OU	00:00:18		
	0.00	MWL	Water Level, 5% of cross sectional area	00:00:18		
	46.55	MWLS	Water Level, Sag in pipe, 85% of cross sectional area	00:03:41		S4
	46.64	S01 MCU	Camera Underwater, Start	00:03:44		
	49.78	F01 MCU	Camera Underwater, Finish	00:04:04		M4
	49.78	MWL	Water Level, 40% of cross sectional area	00:04:05		
	51.75	S02 MCU	Camera Underwater, Start	00:04:24		
	56.32	F02 MCU	Camera Underwater, Finish	00:04:58		M4
	171.03	AEP	End of Pipe / CAMERA LOST TRACTION'	00:36:36		
END						
QSR	QMR	SPR	MPR	OPR	SPRI	MPRI
4100	4200	4.0	8.0	12.0	4.0	4.0

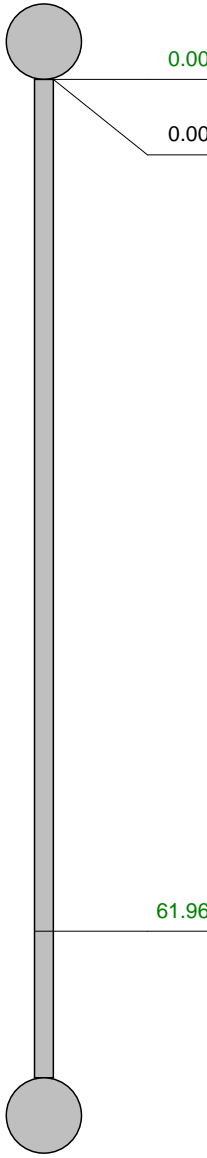
0.00	AMH	Manhole / PW3	00:00:24		
	0.00	MWL	Water Level, 5% of cross sectional area	00:00:25		
	61.96	AEP	End of Pipe / CAN NOT PASS JOINT	00:12:04		
QSR	QMR	SPR	MPR	OPR	SPRI	MPRI
0000	0000	0.0	0.0	0.0	0.0	0.0

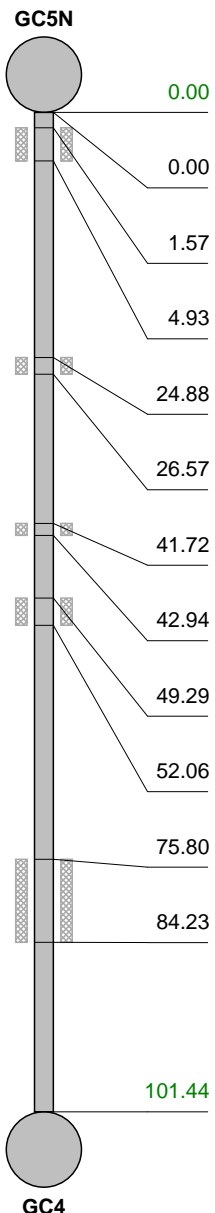
0.00	AMH	Manhole / GC5N	00:00:20		
	0.00	MWL	Water Level, 45% of cross sectional area	00:00:21		
	1.57	S01	MCU	Camera Underwater, Start		
	4.93	F01	MCU	Camera Underwater, Finish		M4
	24.88	S02	MCU	Camera Underwater, Start		
	26.57	F02	MCU	Camera Underwater, Finish		M4
	41.72	S03	MCU	Camera Underwater, Start		
	42.94	F03	MCU	Camera Underwater, Finish		M4
	49.29	S04	MCU	Camera Underwater, Start		
	52.06	F04	MCU	Camera Underwater, Finish		M4
	75.80	S05	MCU	Camera Underwater, Start		
	84.23	F05	MCU	Camera Underwater, Finish		M4
	101.44	AMH	Manhole / GC4	00:21:07		
QSR	QMR	SPR	MPR	OPR	SPRI	MPRI
0000	4400	0.0	16.0	16.0	0.0	4.0

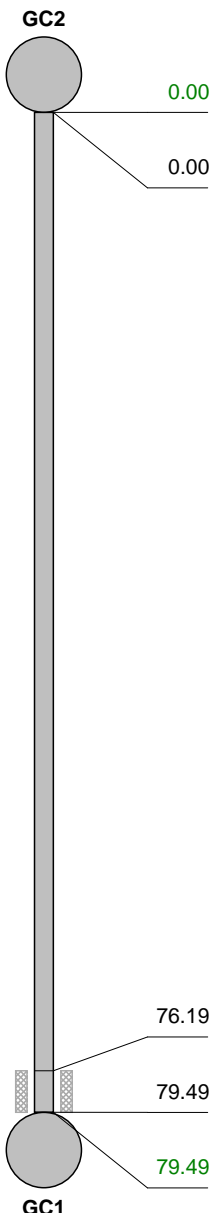
0.00	AMH	Manhole / GC2	00:00:14		
	0.00	MWL	Water Level, 15% of cross sectional area	00:00:15		
	76.19	S01	MCU	Camera Underwater, Start		
	79.49	F01	MCU	Camera Underwater, Finish		M4
	79.49	AMH	Manhole / GC1	00:08:29		
QSR	QMR	SPR	MPR	OPR	SPRI	MPRI
0000	4100	0.0	4.0	4.0	0.0	4.0
