ROADS, PARKS AND FLEET DEPARTMENT MEMORANDUM

RE: ALL-WAY STOP INVESTIGATION FOR MILLER DRIVE AND SPROULE DRIVE

DATE: APRIL 1, 2019

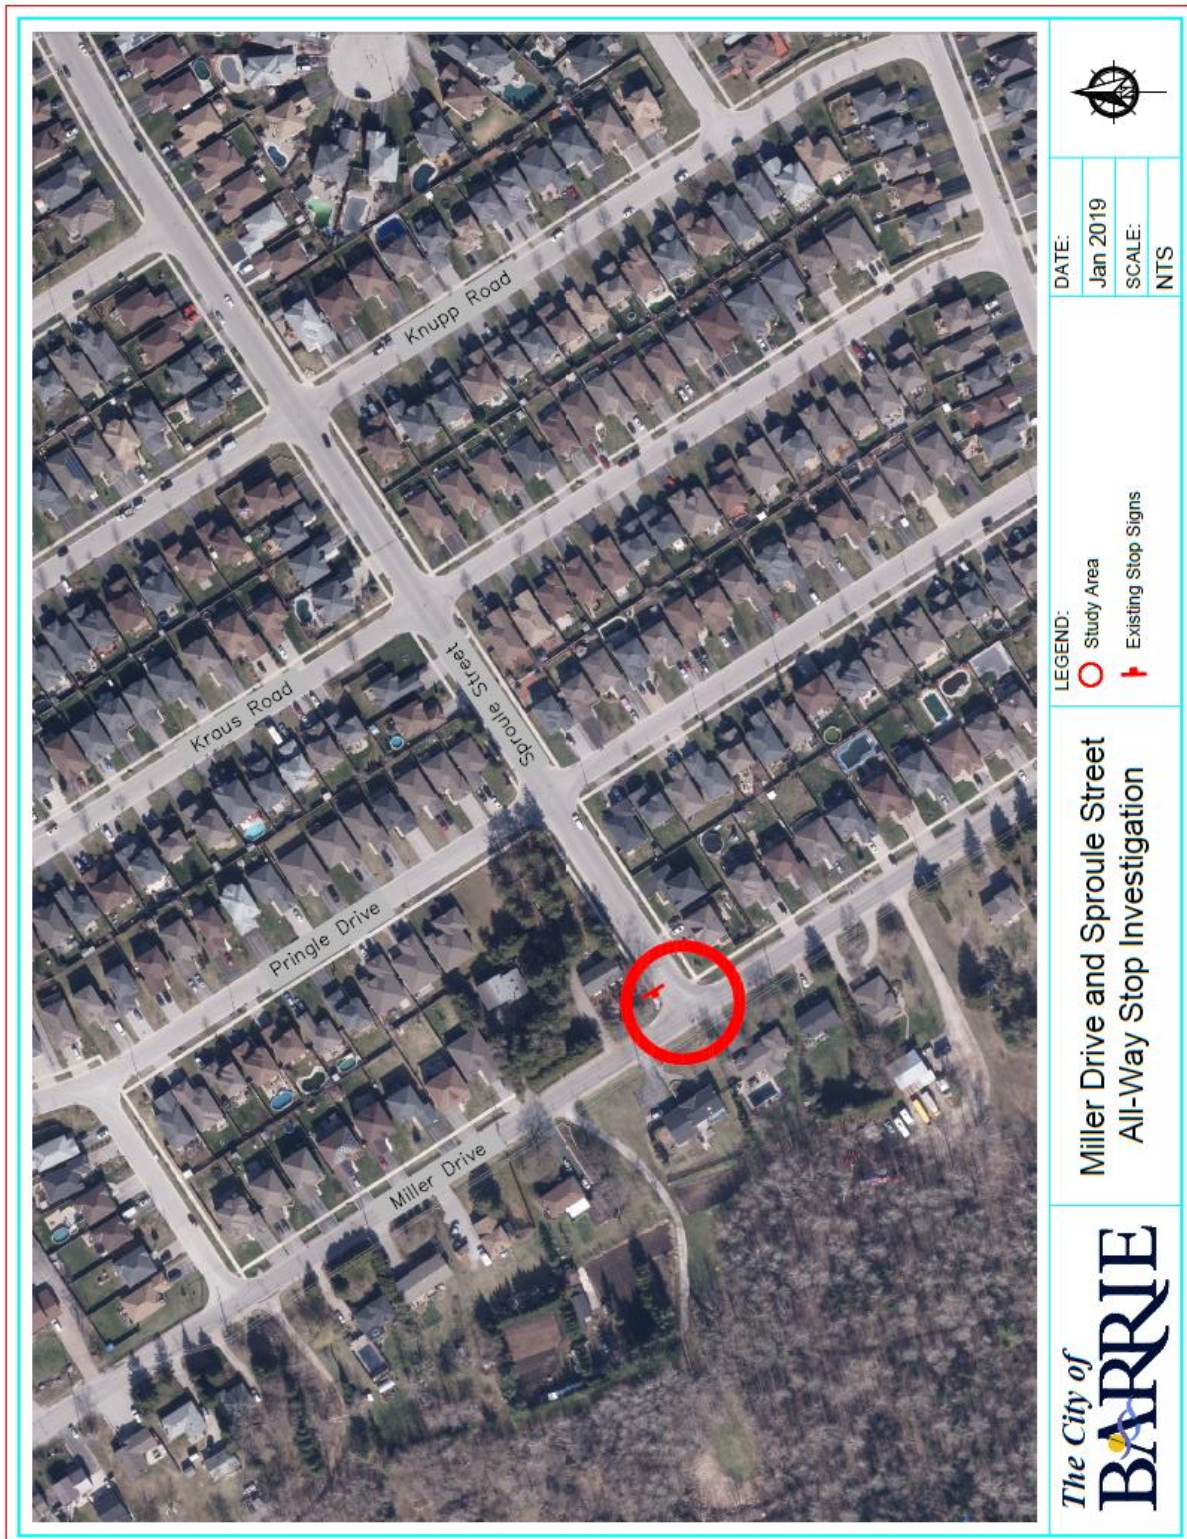
This Memo is in response to the request for an All-Way Stop investigation at the intersection of Miller Drive and Sproule Drive. Currently, the stop control requires vehicles travelling along Sproule Street (Minor Collector Street) to stop at Miller Drive (Minor Collector Street) please refer to Appendix "A" for a map of the study area.
