Table of Contents

1	Introd	uction	1
	1.1 Q	uality Management System	1
	1.2 St	tormwater System Description	2
2		Management and Financial Performance	
		sset Management Plan	
		atchment Inventory

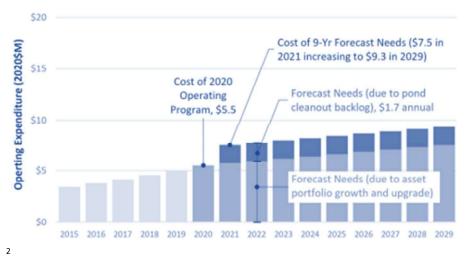
- The total stormwater asset value was \$1,245,000,000.
- 41% of SWMFs were designed for enhanced water quality treatment, without which stormwater will carry higher levels of pollutants into creeks, streams, and lakes, including Lake Simcoe.
- Figure 2 illustrates the projected funding required to operate and maintain the stormwater assets in a state of good repair to maintain the performance standards.
- Operations and maintenance needs associated with a growing asset portfolio will increase operating funding expenditures. For example, the identified SWMF cleanout backlog will result in poor water quality and failure to meet regulatory requirements if not addressed.¹

The Stormwater AM Plan concluded that the City of Barrie has historically underinvested in stormwater assets, noting that underinvestment is unsustainable and will result in more risk in the form of flooding events, infrastructure failures and loss of service.

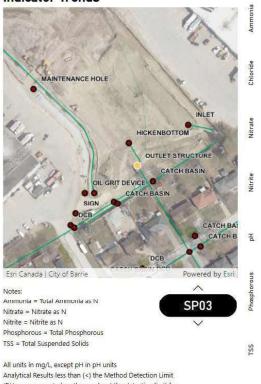
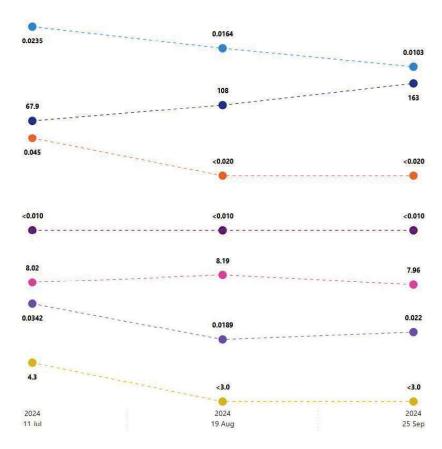
All units in mg/L, except pH in pH units
Analytical Results less than (<) the Method Detection Limit
(DL) are represented on the graphs at the detection limit for
illustration purposes
Each graph is scaled based on the data presented

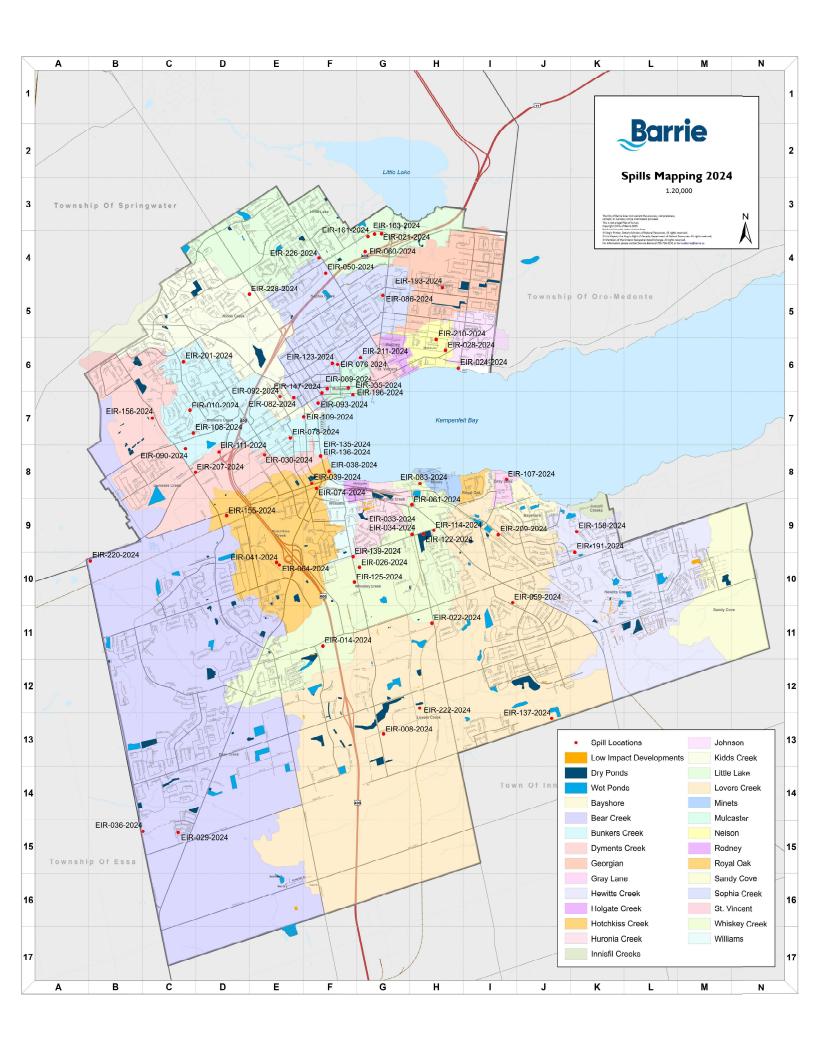
Summary of Spills and Abnormal Discharges

Summary o	of Spills and Abnormal Discharges				
Record ID	Description of Incident	Cause of Spill	Specific Location	Occurrence Date Repo	orted Date
EIR-008-2024	Accident at intersection between tranposrt truck and SUV Spill of diesel to ditcl	n	On Saunders Road in front of 161 Saunders Road	2024-01-26	2024-01-26
	Car drove off of the roadway and crashed into the electrical box on the	·	on Saanaers nead in none of 101 Saanaers nead	20210120	
	boulevard in front of 100 Fox Run Mineral oil leaked onto the roadway and into				
EIR-010-2024	the storm catch basin in front of 95 Fox Run	Mineral oil leaking from damaged electrical box.	On the boulevard in front of 100 Fox Run.	2024-02-05	2024-02-05
	Due to the melt and steep slopes on the construction site sediment is entering				
EIR-014-2024	into the watercourse Whiskey Creek	Silt laden runoff from construction site.	Bryne Drive Extension work at Harvie Road.	2024-02-09	2024-02-09
