то:	GENERAL COMMITTEE
SUBJECT:	CUMMING DRIVE TRAFFIC CALMING UPDATE
WARD:	6
PREPARED BY AND KEY CONTACT:	J. MACDONALD, C.E.T. SENIOR TRANSPORTATION OPERATIONS TECHNOLOGIST (EXT. 5178)
SUBMITTED BY:	D. FRIARY DIRECTOR OF ROADS, PARK AND FLEET
GENERAL MANAGER APPROVAL:	R. FORWARD, MBA, M.Sc., P. Eng. GENERAL MANAGER OF INFRASTRUCTURE AND GROWTH MANAGEMENT
CHIEF ADMINISTRATIVE OFFICER APPROVAL:	M. PROWSE, CHIEF ADMINISTRATIVE OFFICER

1. That Staff Report RPF010-17 on the Cumming Drive Traffic Calming update be received for information purposes.

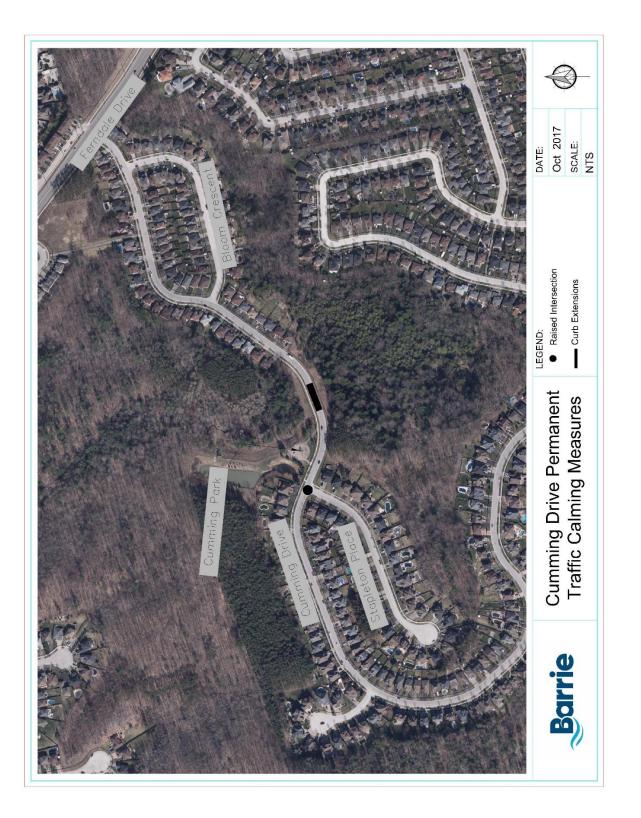
Appendix A

- a) Raised intersection at Cumming Drive and Stapleton Place; and
  - b) Curb bump outs on Cumming Drive near Cumming Park.
- 4. Cumming Drive is a local roadway with a pavement width of 8.5 metres, sidewalk on the north side and a daily volume of 1,300 vehicles. Please refer to Appendix "A" for the study area.
